Tanker Structure and Hull Failure Strength

Hajime Kawano and Masaru Hirakata,
National Maritime Research Institute, Japan.

3-2. Case study

Outline of the Nakhodka casualty

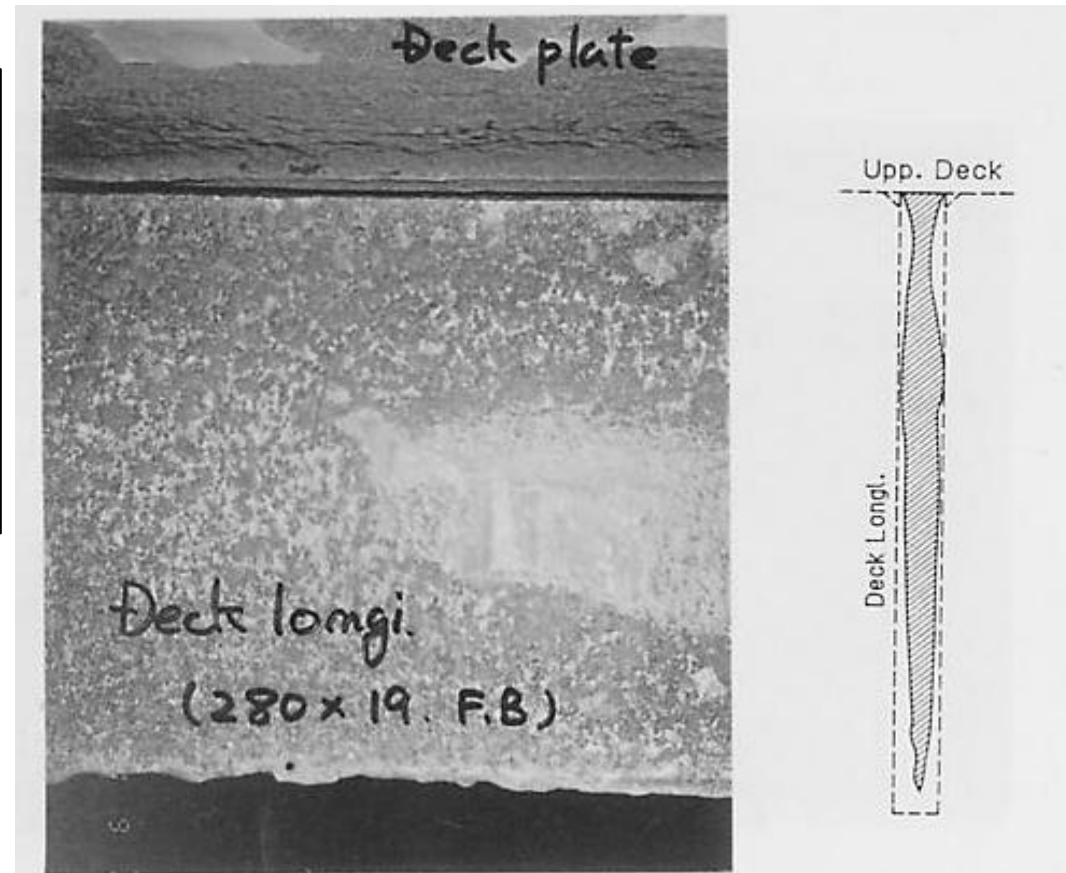
Corrosion wastage in deck longitudinal of WBT, with poor fillet weld and sharp edge at depth end. (aged 15 years)

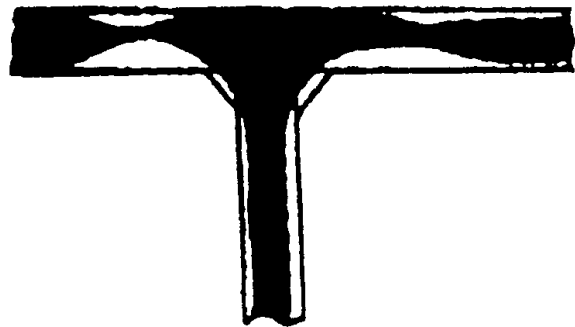
Typical local corrosion on stringer: below

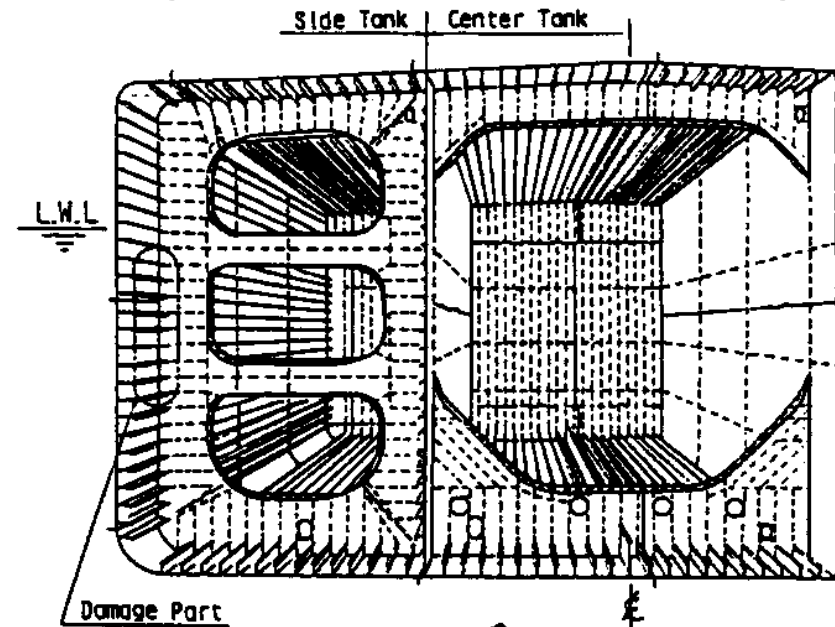
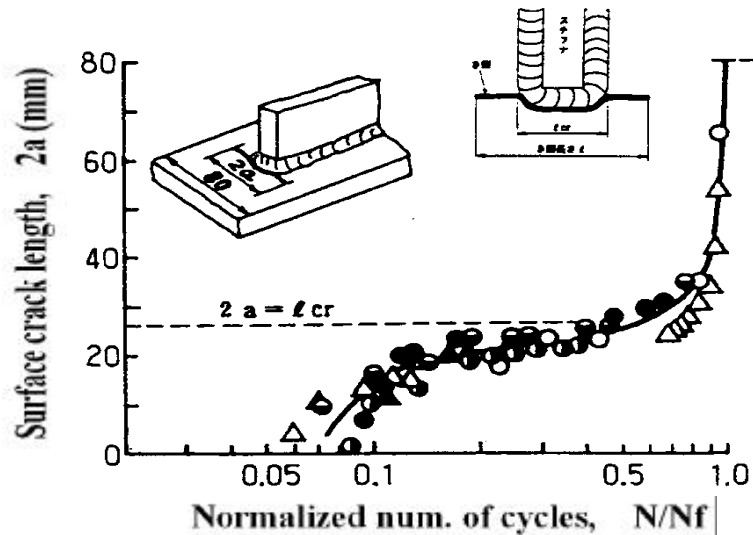
Fatigue crack at side longitudinal, in 2nd generation VLCC damages.

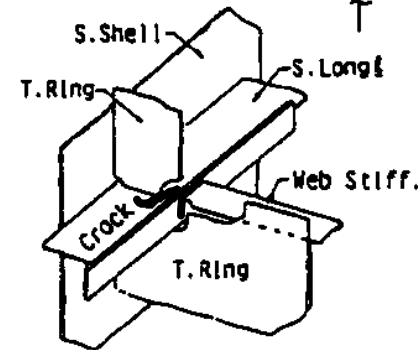
Fatigue crack growth at fillet welded corner.

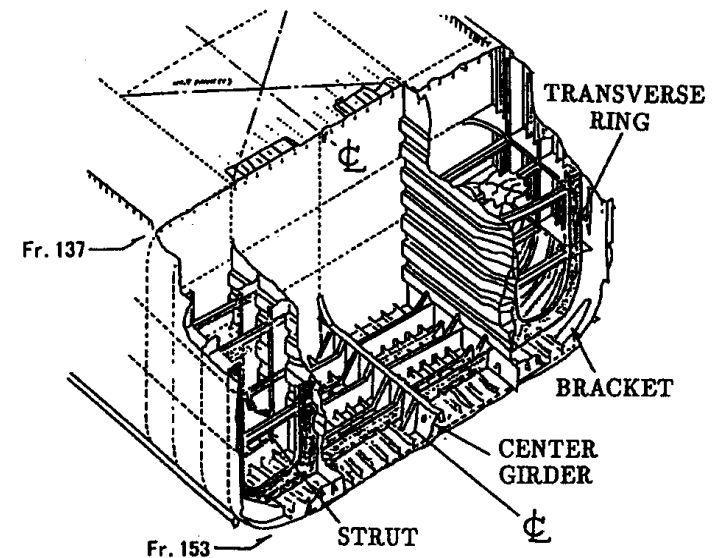
Fr.137 Fr.153
Failed and broke in two

Fractured cross-section of hull girder at sea bottom

- (1) *Excessive corrosion* made the Nakhodka's vertical bending strength about one half to that of as built.
- (2) So, the most *severe wave load* in a year at Japan sea, let her broke up.
- (3) In addition to the above, the *non-standard loading pattern* at the accident had enlarged the wave load.

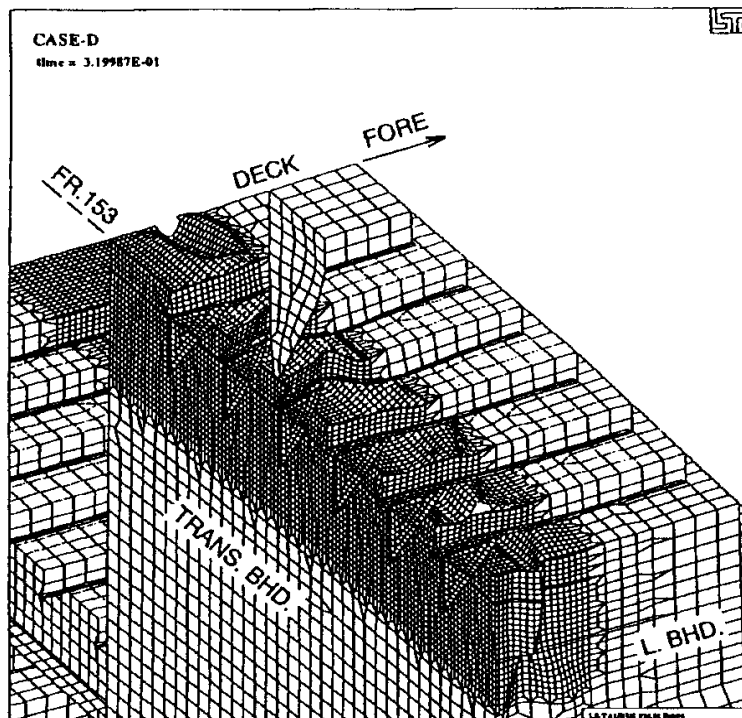
(a) collapse mode at deck

**Simulation result showed ;
the break-up started at the deck structure on about Fr.153.**
