INTERNATIONAL TANKER OWNERS  
POLLUTION FEDERATION LIMITED

## *Oil Spills in Cold Water: Lessons Learned*

PAJ Symposium  
Tokyo, Japan  
February 2005

Stéphane Grenon  
Technical Adviser  
ITOPF

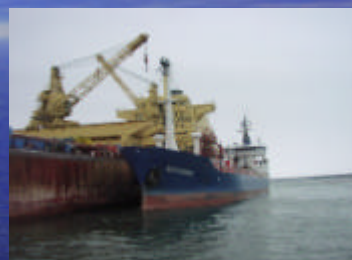
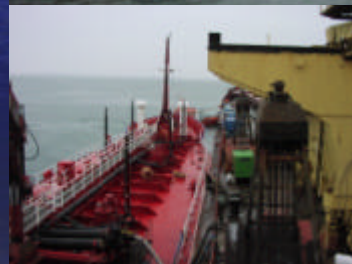
- Lightering operation
  - Cement (4000 tonnes)
  - HFO (900 m<sup>3</sup>)
- Estimated spill between 50-100m<sup>3</sup>

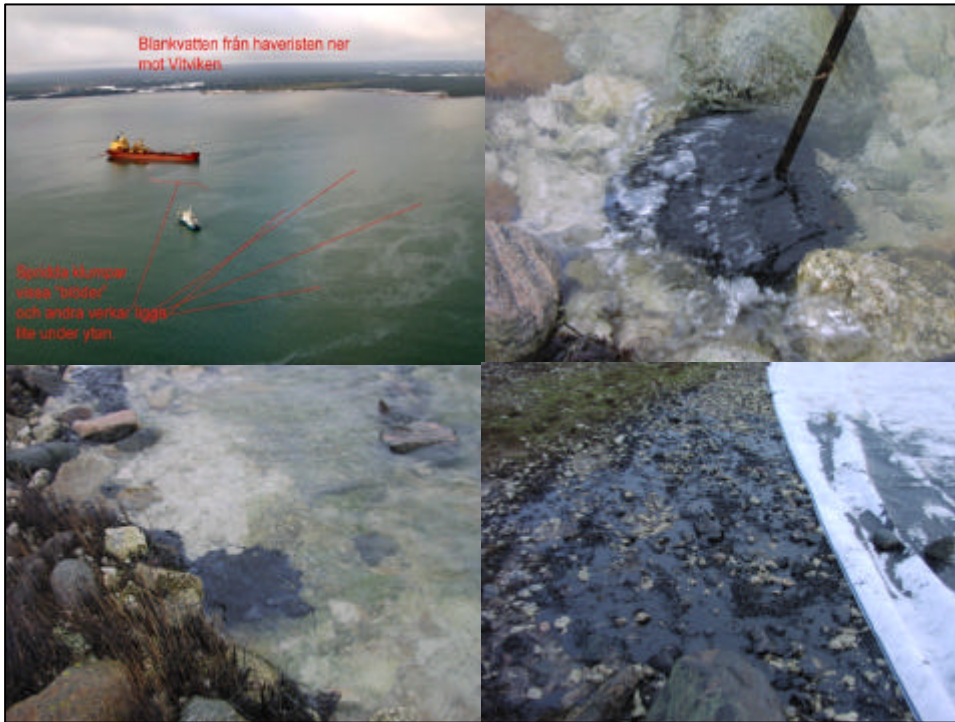
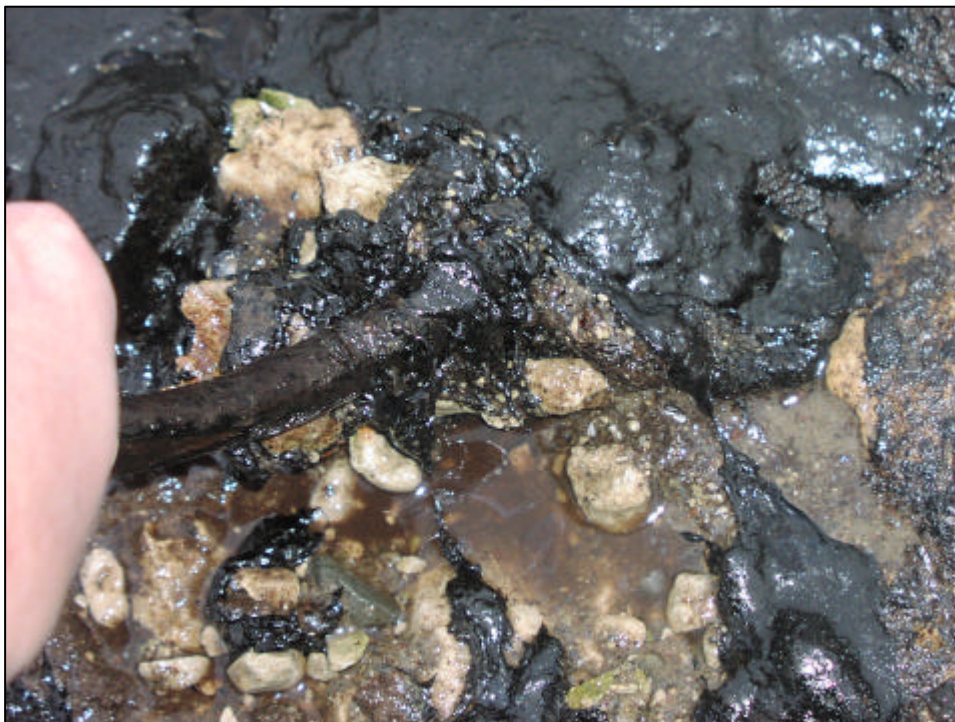
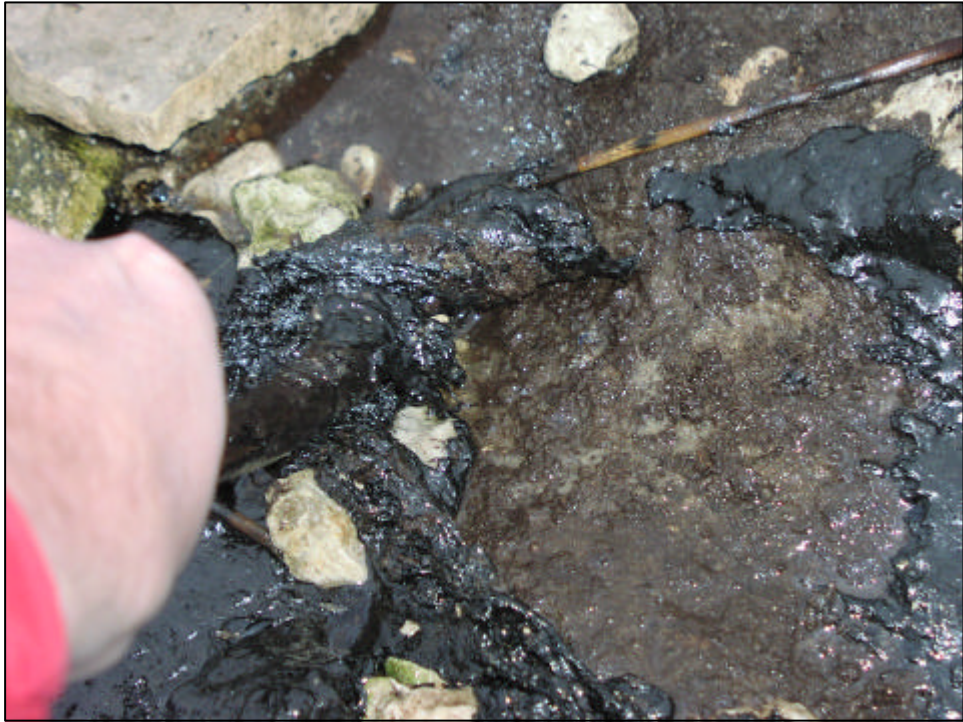
- Tar balls and pancakes visible in vicinity of ship
  - No oil observed on water
  - But oil washing up on shoreline?
- Submerged oil (10 cm to 1m depth)

- Why?
  - Oil density (0.9901 at 15<sup>0</sup>C)
  - Water temperature 4<sup>0</sup>C
  - Low water salinity (10<sup>0/00</sup>)
- Oil density increased above water density
  - Submerged oil

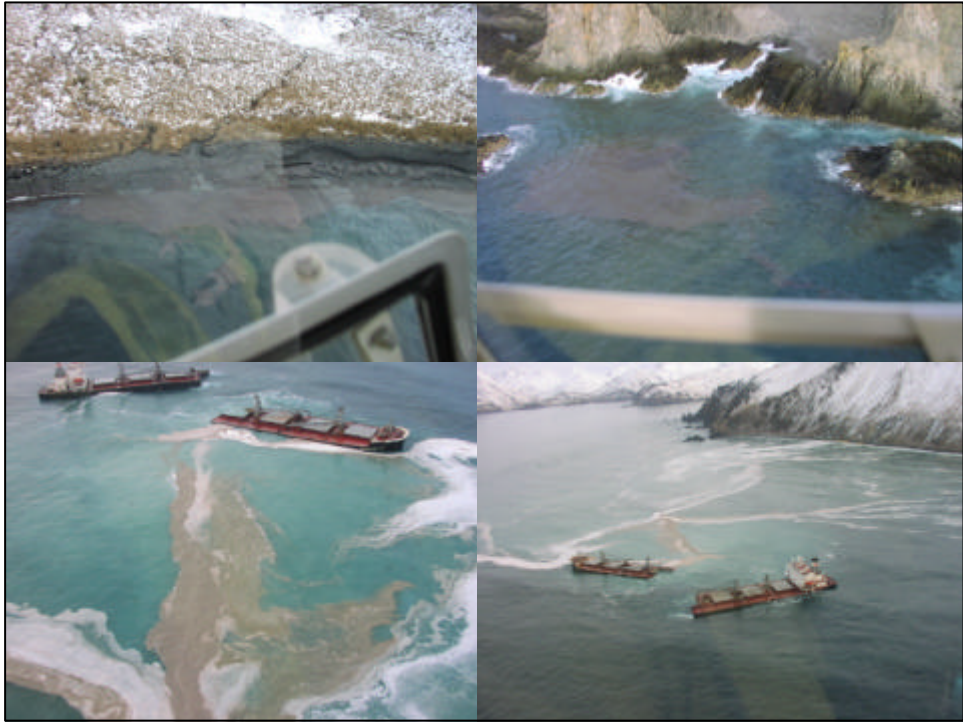
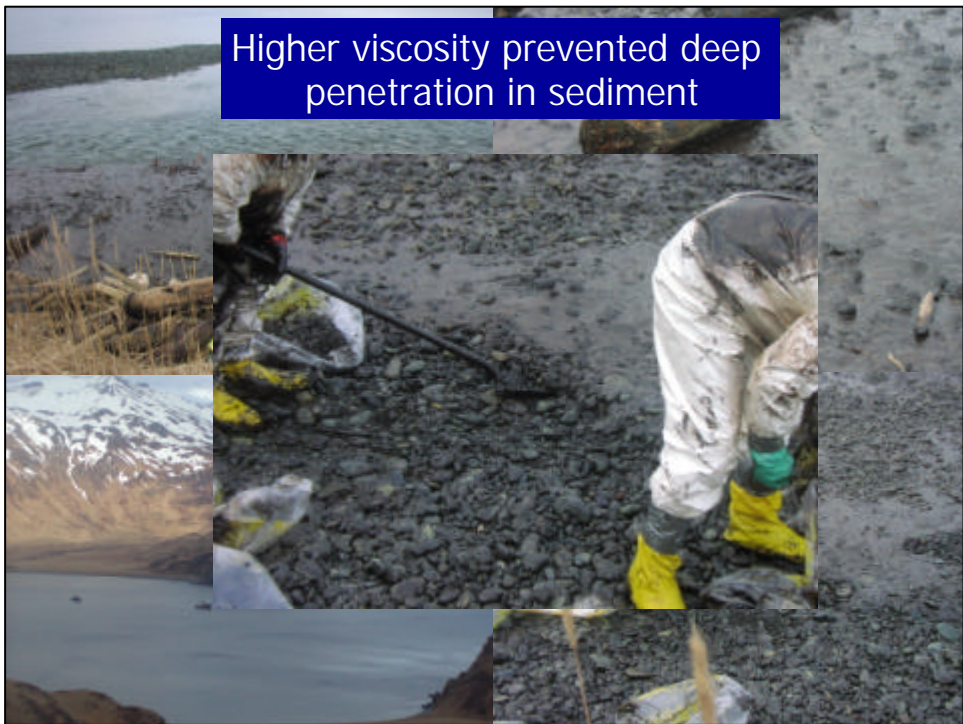
- Floats
  - Slicks
  - Tar balls
- Increased viscosity
  - Cold temperature (3°C)
  - Emulsification
- Small amount of oil in ice
