Summary of Chemical Tanker Accident at Kumano-nada, Japan

Mitsuyoshi NOMATA
Director,

Marine Environment Protection & Disaster Prevention
Division, Guard & Rescue Department
Japan Coast Guard

Outline of the Accident

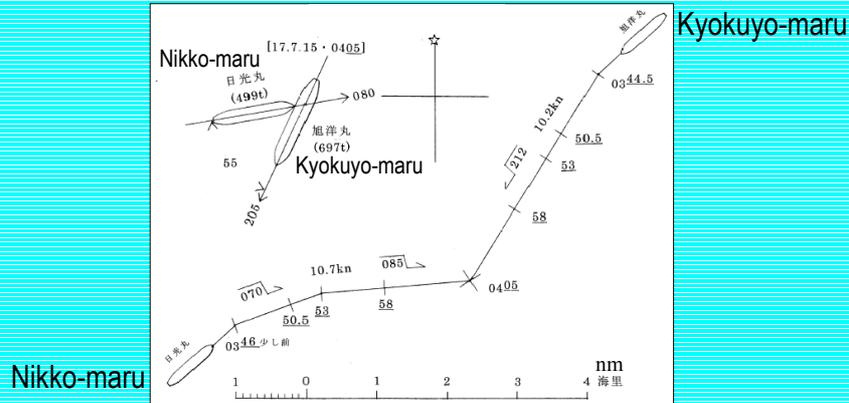
Geometrical relation of the two vessels when the collision took place

- Nikko-maru's bow collided with Kyokuyo-maru's starboard-side bridge.
- 2 of the 7 crew members of Kyokuyo-maru jumped into the sea (one of them died).
- The remaining five were missing. → Search and rescue operation was undertaken at sea. → A Special Rescue Team searched for them in the vessel before the fire was completely extinguished and discovered the remains of the five missing crew members.

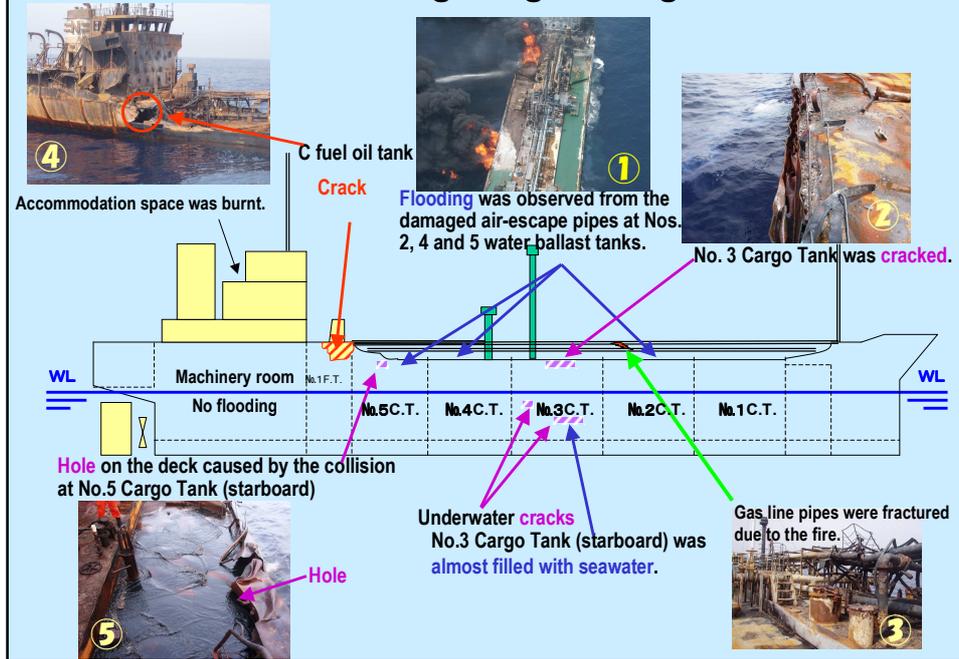
Results of investigating damage to the hull

- Possible re-ignition due to continued leakage of flammable gas from the cracks on the hull

- With 20-degree heel to the starboard side, risk of overturning and submergence increased
