# OPERATION GULFSTREAM 2024

A Case Study

Tobago, The Republic of Trinidad and Tobago

QT Environmental, Inc.

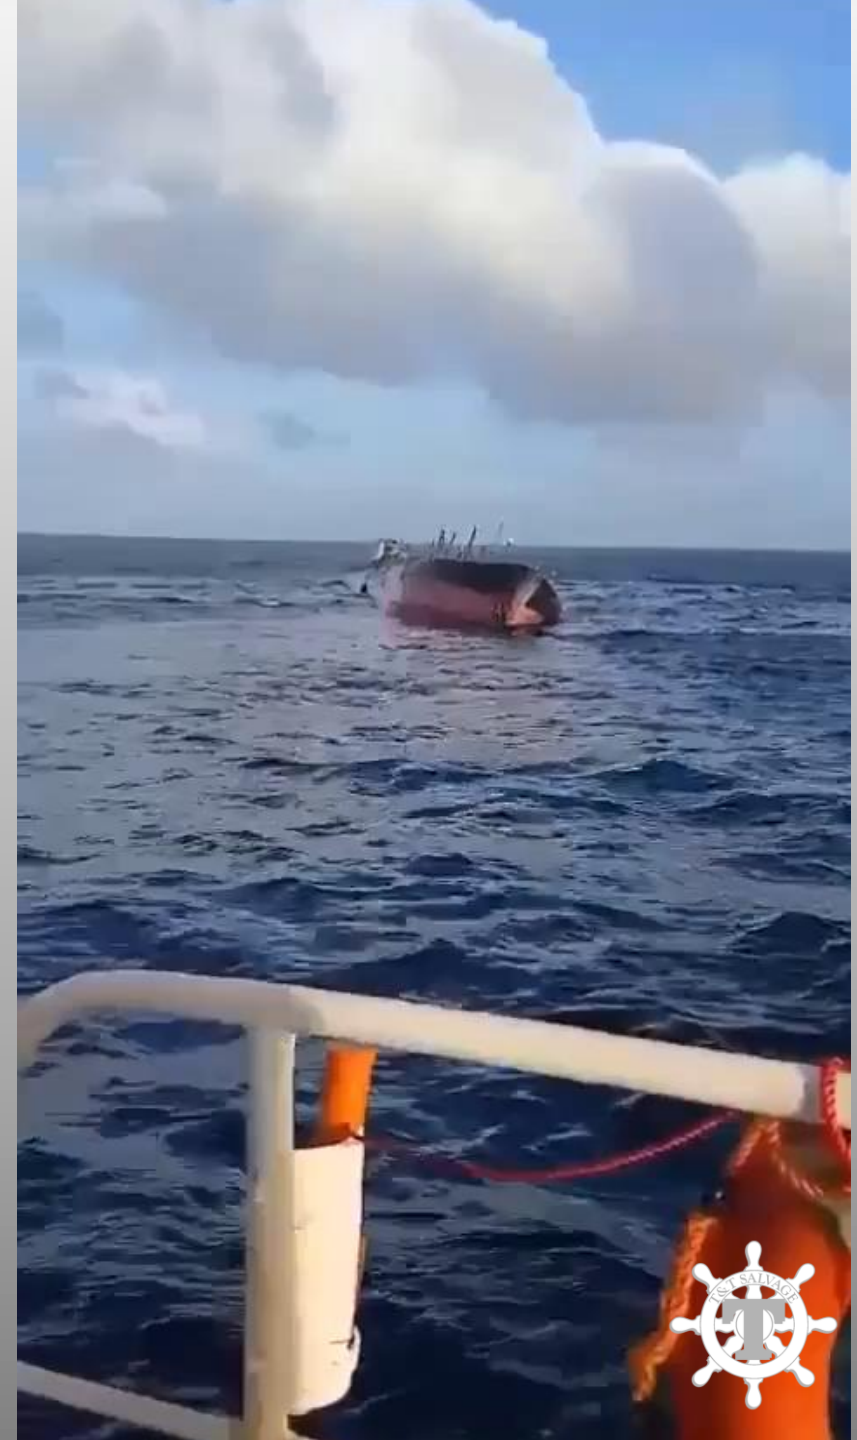
BUILT IN 1976  
MODIFIED COUNTLESS TIMES –  
DRAWINGS CONFLICT EACHOTHER

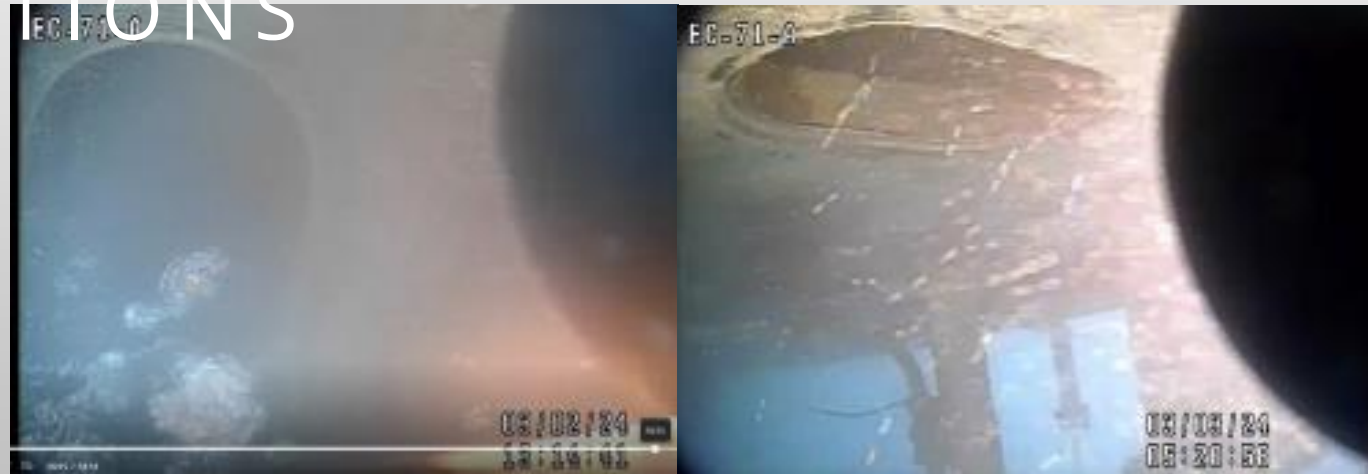
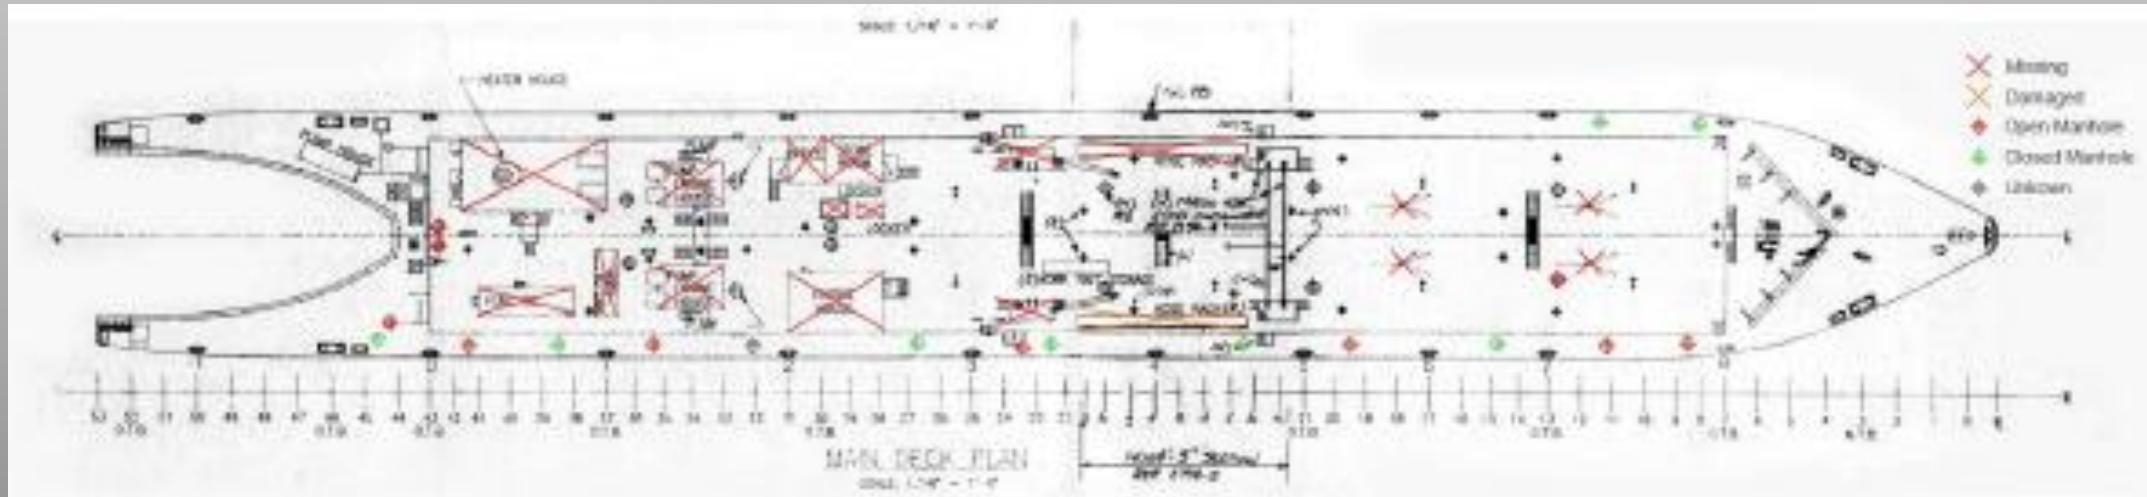
Cargo tanks 6 Port and 6 Starboard were found accessible with their manhole covers missing during the dive survey. It is unknown how much hydrocarbon remains in these tanks at the present time. It is also unknown what was in these tanks both cargo type and quantity prior to the capsizing of the barge.

T&T Salvage would propose a sampling of these tanks with divers and pumping equipment. The risk of additional pollution is low since the manhole covers are already open.

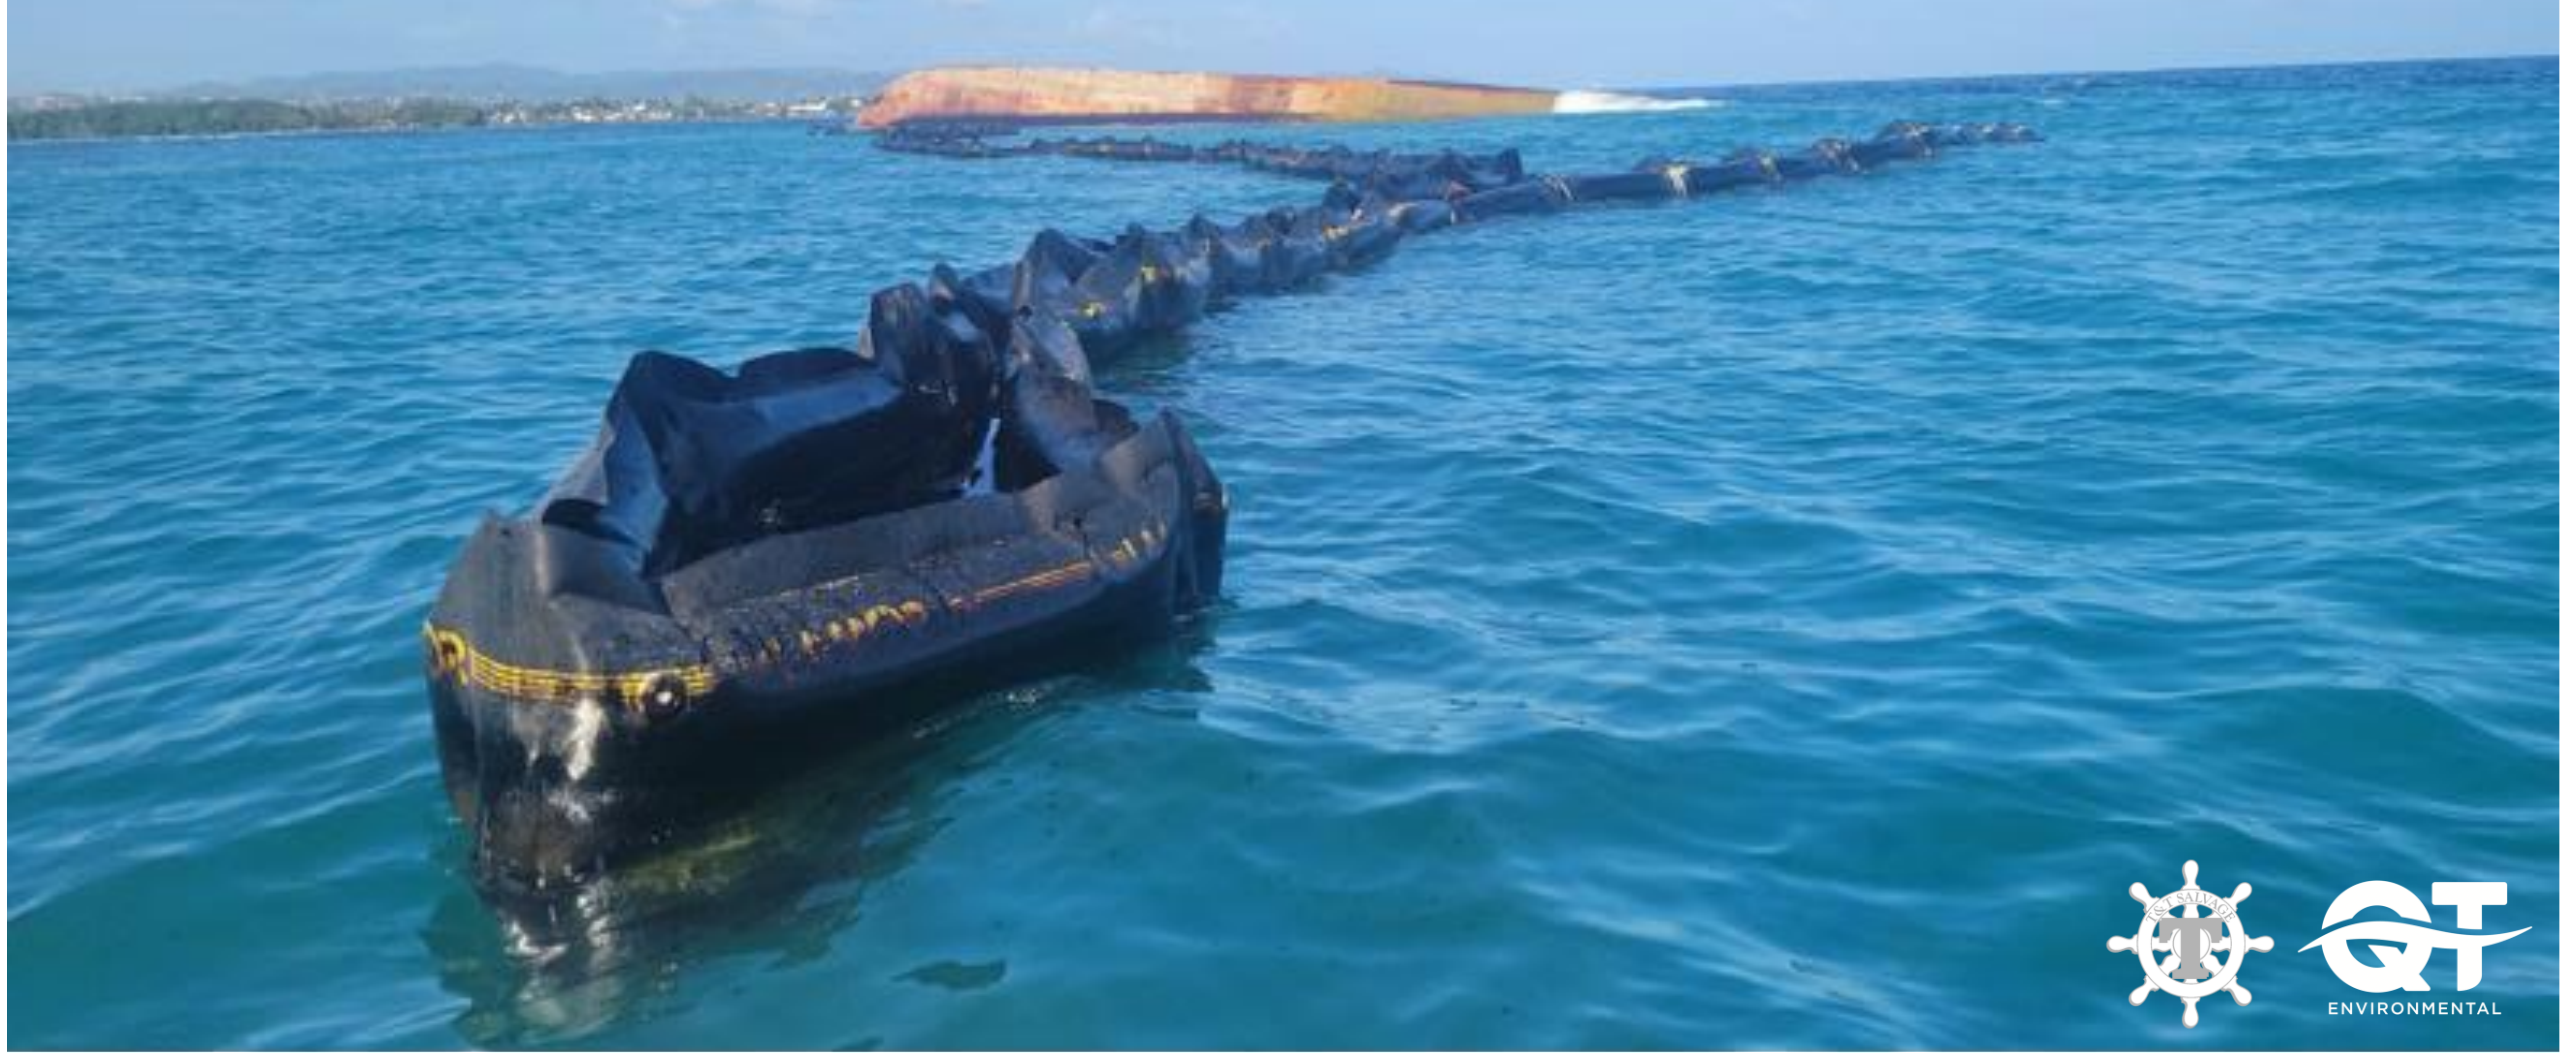
ENTRAINMENT  
AT APEX

ENTRAINMENT  
AT SWATH

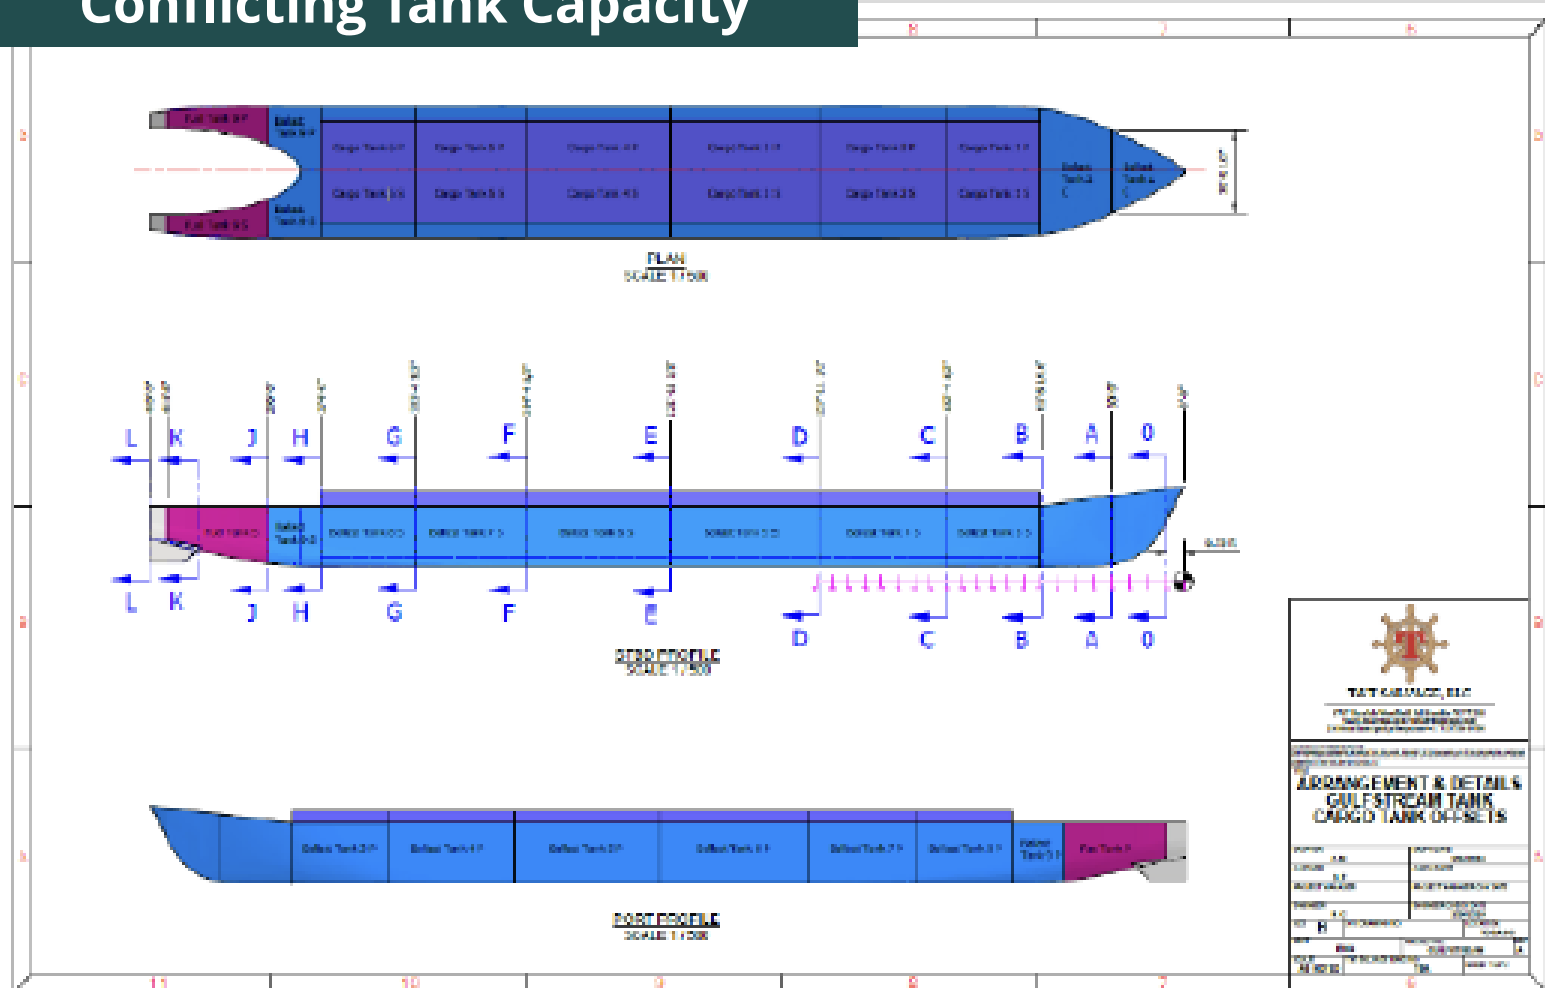
Identification of Ship's Tanks	Capacity
1P) Cargo Tank	4348.54 Bbls
1S) Cargo Tank	4354.28 Bbls
2P) Cargo Tank	6065.39 Bbls
3S) Cargo Tank	6027.19 Bbls
3P) Cargo Tank	6939.69 Bbls
3S) Cargo Tank	6935.15 Bbls
4P) Cargo Tank	6814.40 Bbls
4S) Cargo Tank	6811.23 Bbls
5P) Cargo Tank	5258.17 Bbls
5S) Cargo Tank	5254.05 Bbls
6P) Cargo Tank	4424.94 Bbls
6S) Cargo Tank	4412.31 Bbls

MISC. TANKS CAPACITY				
TANK	FRAME NO.	CAPACITY (GALLONS)	VCG (FEET)	LCG (FEET)
HOT OIL EXP TANK	37	3,366	42.50	260.27
HYD OIL STORAGE TANK	28	1,200	36.90	201.30
DIESEL OIL DAY TANK	38-41	4,922	38.50	281.00
DIESEL OIL STORAGE TK (P)	46-53	64,549	16.33	343.29
DIESEL OIL STORAGE TK (P)	46-53	64,549	16.33	343.29

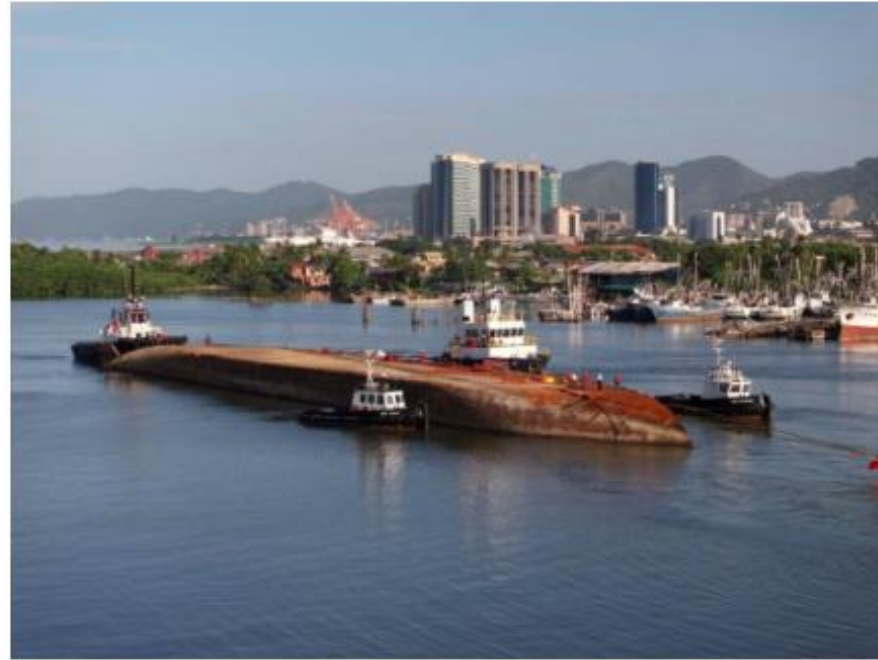
**The Gulfstream's arrival at Sea Lots, Port of Spain on August 22. - Photo courtesy the Ministry of Energy**
