### 1. Accident Outline

# 2. Key Facts about the Jane

# 2. Key Facts about the *Hebei* Spirit

## 3. Japan's Response

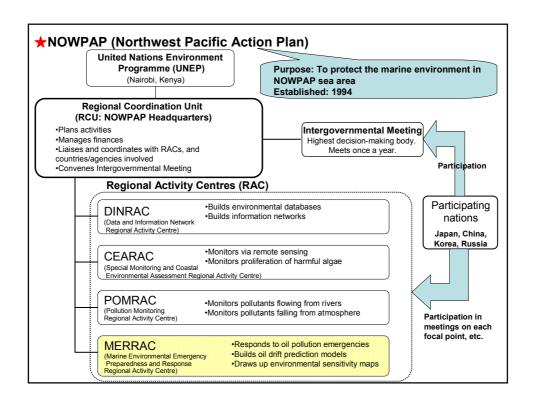
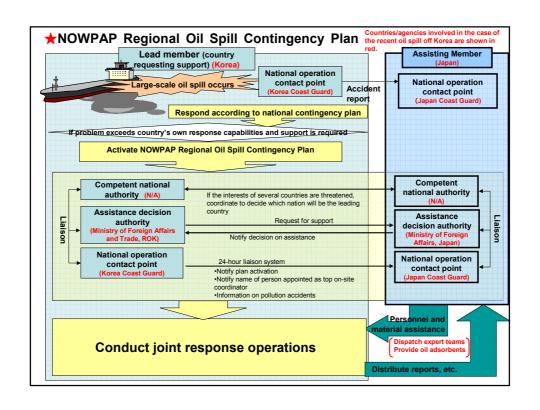
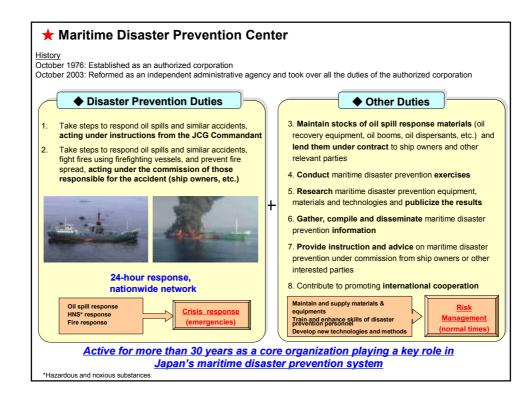
Exchange of views

Cooperation in recovery methods
