The NAKHODKA Jan 2, 1997

The Massive Oil Lumps in the Western Offshore of the Noto Peninsula. 11-12 Jan.

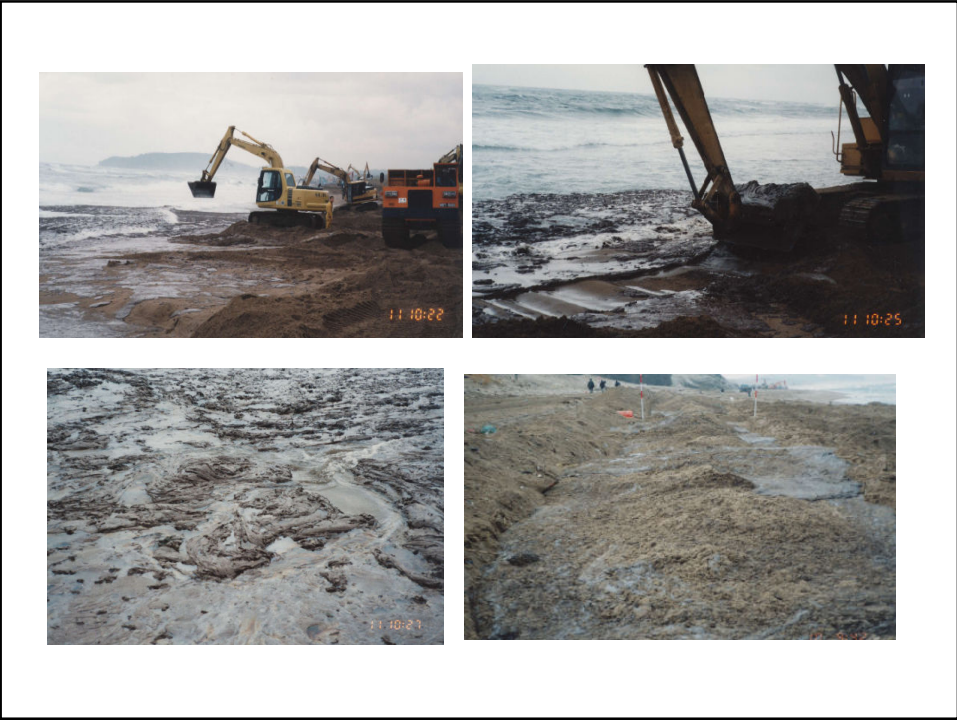
Observation on 6 Mar.

① 舌を出したような油塊
① Oil lump that looks like a sticking out tongue

② ころころ動く油塊
② Oil lumps rolling over

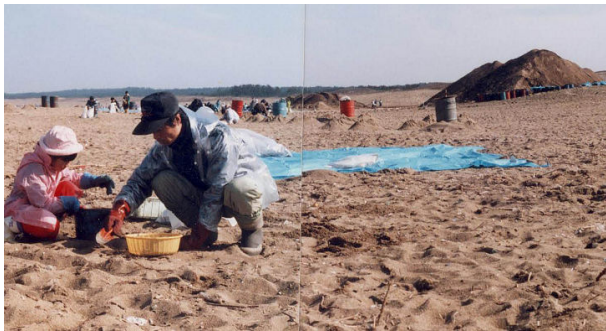
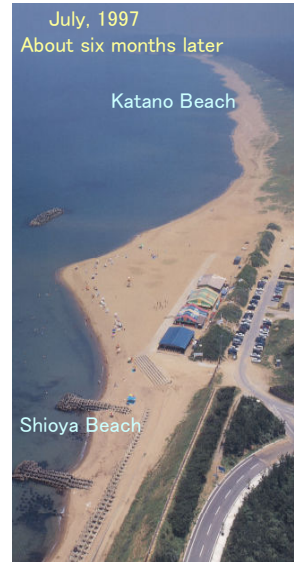
The Kaga Beach

- 5,000 tons of oiled sand → Buried in a landfill site
- Heavily oiled sand → Burnt
- Damage to vegetation → The geographical features of the shore were changed

- The usage of heavy machinery caused a massive amount of sand to be mixed with the oil.
- The geographical features of the shore were changed by being moved landward due to damage to vegetation by heavy machinery.
- A massive amount of the beach sand was contaminated with oil, which was wasted and disposed of. However, there were not enough disposal methods or facilities for the oily waste.
- Examination of the most suitable recovery methods --deployments of suction tanker trucks, beach cleaning machines, and etc.

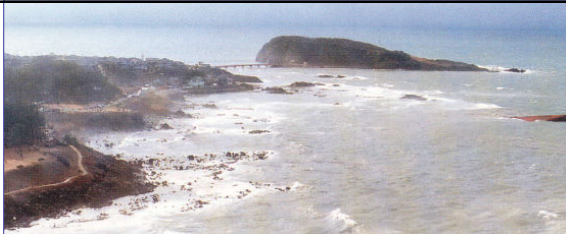
Jan 7, 1997
Mikuni in Fukui Pref.

2,800kl of oil remained inside the bow section.

The MDPC was ordered by the Japanese Gov't to execute the task on 14 Jan.

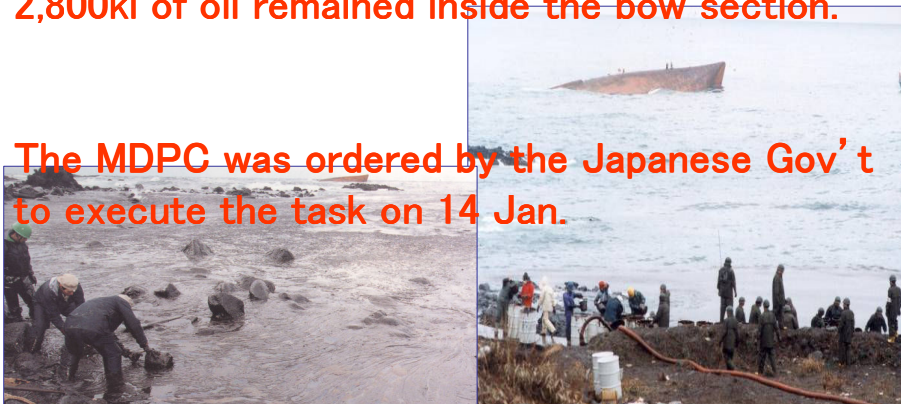
From the Seaside

During calm sea conditions, the extraction operation was done through the night, 3 times in total. A total of 2,800kl of oil-water mixture was collected.

- Extraction is commonly conducted by connecting a hose between the wrecked/grounded vessel and the ground, and pumping out the remaining oil inside the vessel.
- In the case of the other incidents that require a construction of a causeway to collect spilt oil in the future, objectives and problems should be clearly stated.

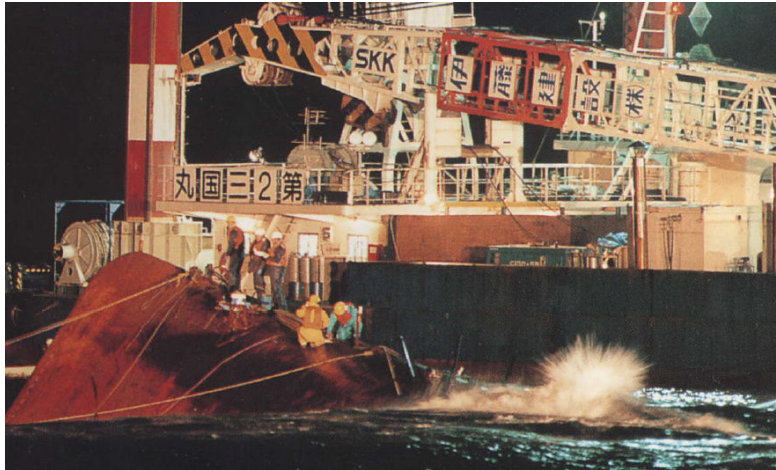
Construction of the Temporary Causeway

Soil and sand were washed out and eroded by waves, and it took 26 days for the causeway to be completed.

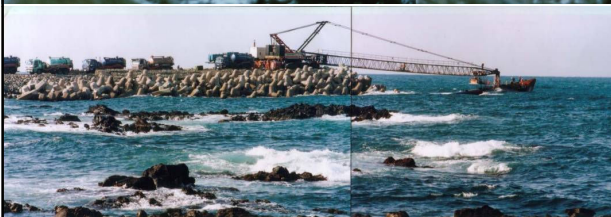
The extraction of the remaining oil. 15 Feb
