The Nakhodka Case; Lessons Learned and Problems to be solved

Outline of the incident

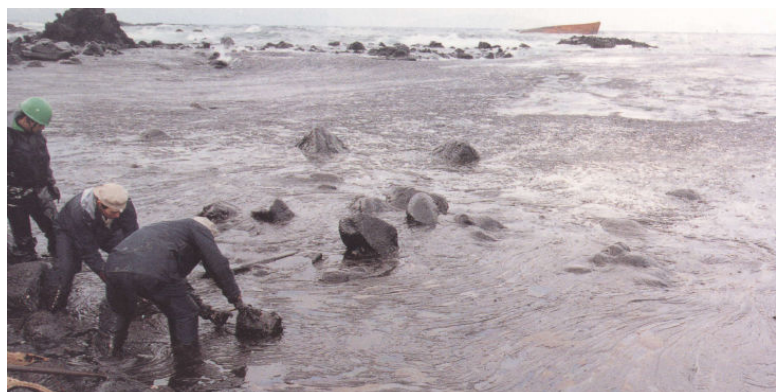
**Fig 1 January 9
Washed up oil and the bow
section grounded on the
coast of Mikuni Town.**

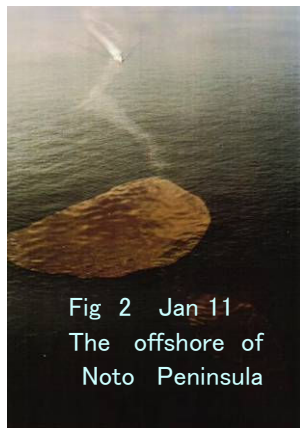
Fig 2 Jan 11
The offshore of
Noto Peninsula

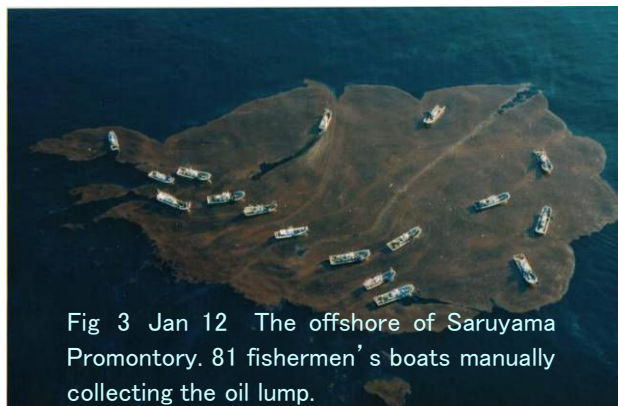
Fig 3 Jan 12 The offshore of Saruyama
Promontory. 81 fishermen's boats manually
collecting the oil lump.

Consequently, recovery work of those oil lumps were only done manually by fishing boats, which was only a small amount. Most of the rest of the oil lumps were washed up on the shore of the northern side of Noto Peninsula. Some of the fishermen who were engaged in the recovery operation later stated that they had collected an oil lump, which was about 70cm thick, by cutting it off with a knife.

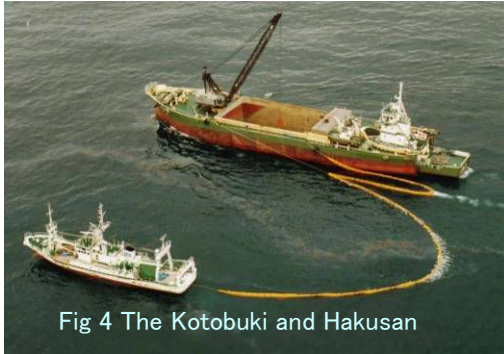
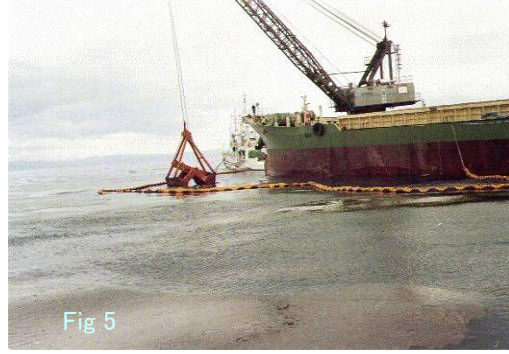
On the morning of January 12th, the grab hopper barges Kotobuki and Hakusan jointly laid a boom on the offshore of the Noto Peninsula and began searching for massive oil lumps but only recovered some smaller ones. Although it was originally planned to use a large type of boom, since it was too difficult to be loaded on the vessel, a small type (B-type) of boom was used instead. As the result, the volume of oil recovered offshore by the Kotobuki during those two days on 12th and 13th January was 450 tons. The usage of the boom was not very successful due to its structural problems and other issues.

- 1 Even though it was known that there were massive lumps of oil in advance, they were not collected by a bucket grab hopper barge or an oil recovery boat.
- 2 The structure of recovery boats in our hand are unsuitable for highly viscous oil recovery operations.
- 3 Further development of techniques of spilt oil recovery with booms is necessary.
- 4 Since the efficiency of a bucket grab hopper barge was not officially known, it was difficult to have an agreement of increase the usage of the barge.
- 5 It took so long (about three hours) for an aircraft to convey the information to the MDPC regarding the locations of oil lumps that the information was no longer useful when it was finally received.

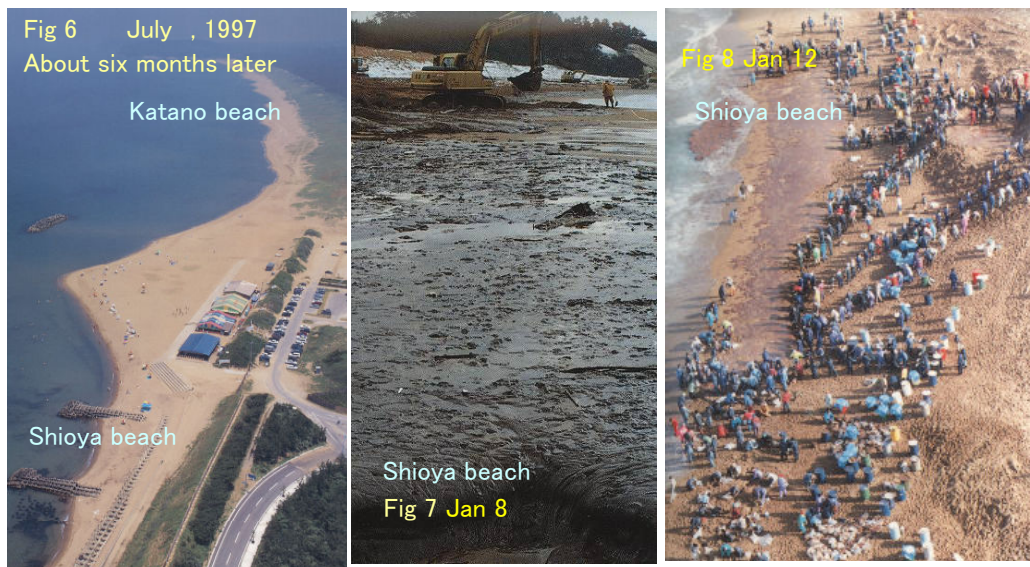
- (1) We observed oil drifted ashore landward across the intertidal zone due to rough weather. The sand beach between Shioya and Katano of Kaga City, Ishikawa Prefecture, which is about 3.8km long, has abundant vegetation. During the stormy night of January 8th, a massive amount of spilt oil washed up on this particular beach. The next morning the sea condition became calm and oil recovery work was done by dozens of heavy machineries such as backhoe and other equipment. The collected oil was either buried into dug holes on the beach or piled up by being moved around by those machines for some time, which made the beach sand mixed up with lots of oil. Therefore, a large number of volunteers had to manually separated the oil from the sand and collected it later on. The volume of collected oiled sand was about 5,200 tons, which was later burnt or disposed of in a landfill site. The shoreline, over several years of observation, was shown to be severely eroded. In the future, in order to deal with massive oil spills washed ashore on the beach like in this case, we need to plan and examine methods of collecting it.

- 1 The usage of heavy machinery caused a massive amount of sand to be mixed with the oil.
- 2 The geographical features of the shore were changed by being moved landward due to damage of vegetation by heavy machinery.
- 3 A massive amount of beach sand was contaminated with oil, which was wasted and disposed of. However, there is not enough disposal methods or facilities for oily waste.
- 4 Examination of the most suitable recovery methods
 - deployments of suction tanker trucks, beach cleaning machines, and etc.

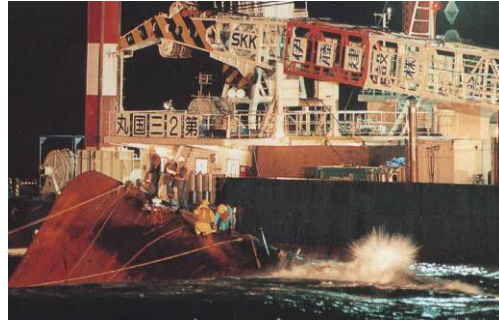
Fig 9

Work vessels started the operation by opening a hole on the bottom plate of the Nakhodlka, from which they pumped out the remaining oil and collected it into tankers aside. The extraction work was done by a joint venture of two salvage companies for three times in total during calm sea conditions. A total of 2,800kl of oil-water mixture was collected.

During calm sea conditions, the extraction operation was done all night long.

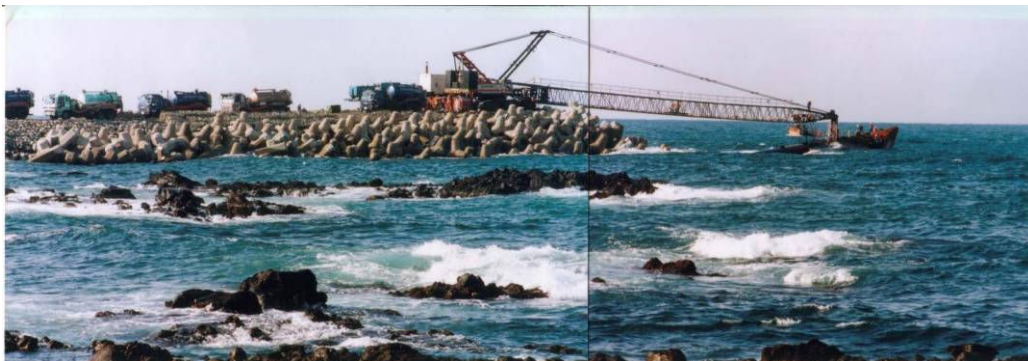
Fig 10

On the shore side, a temporary causeway was constructed to reach the bow section of the ship from the shore, which was 130m long, in order to carry out the extraction work regardless of the sea conditions. This construction ended up using a total of 58,000 tons of large and small sizes of rocks and tetra pods. When originally planned, it was expected to be constructed within a week, but soil and sand were washed out and eroded by waves, and it took 26 days from January 15th through February 9th for the causeway to be finished.

The extraction work from the temporary causeway

- 1 In Japan, we have had several experiences of tanker incidents that they drifted ashore with large amount of oil in the tanks and, it was common manner to extract oil by hose line installed from wrecked to work vessel brought alongside.
- 2 In the case of construction of temporary causeway, it is required to clarify every aspect of planning, implementation procedure, matter of concern to the parties, demolition and financial matters by all means..
