DEVELOPMENTS IN SPILL RESPONSE

+ ILLUSTRATIVE CASE STUDY

15th February 2024
PAJ Oil Spill Workshop 2024

CASE STUDY:
**PRINCESS
EMPRESS**

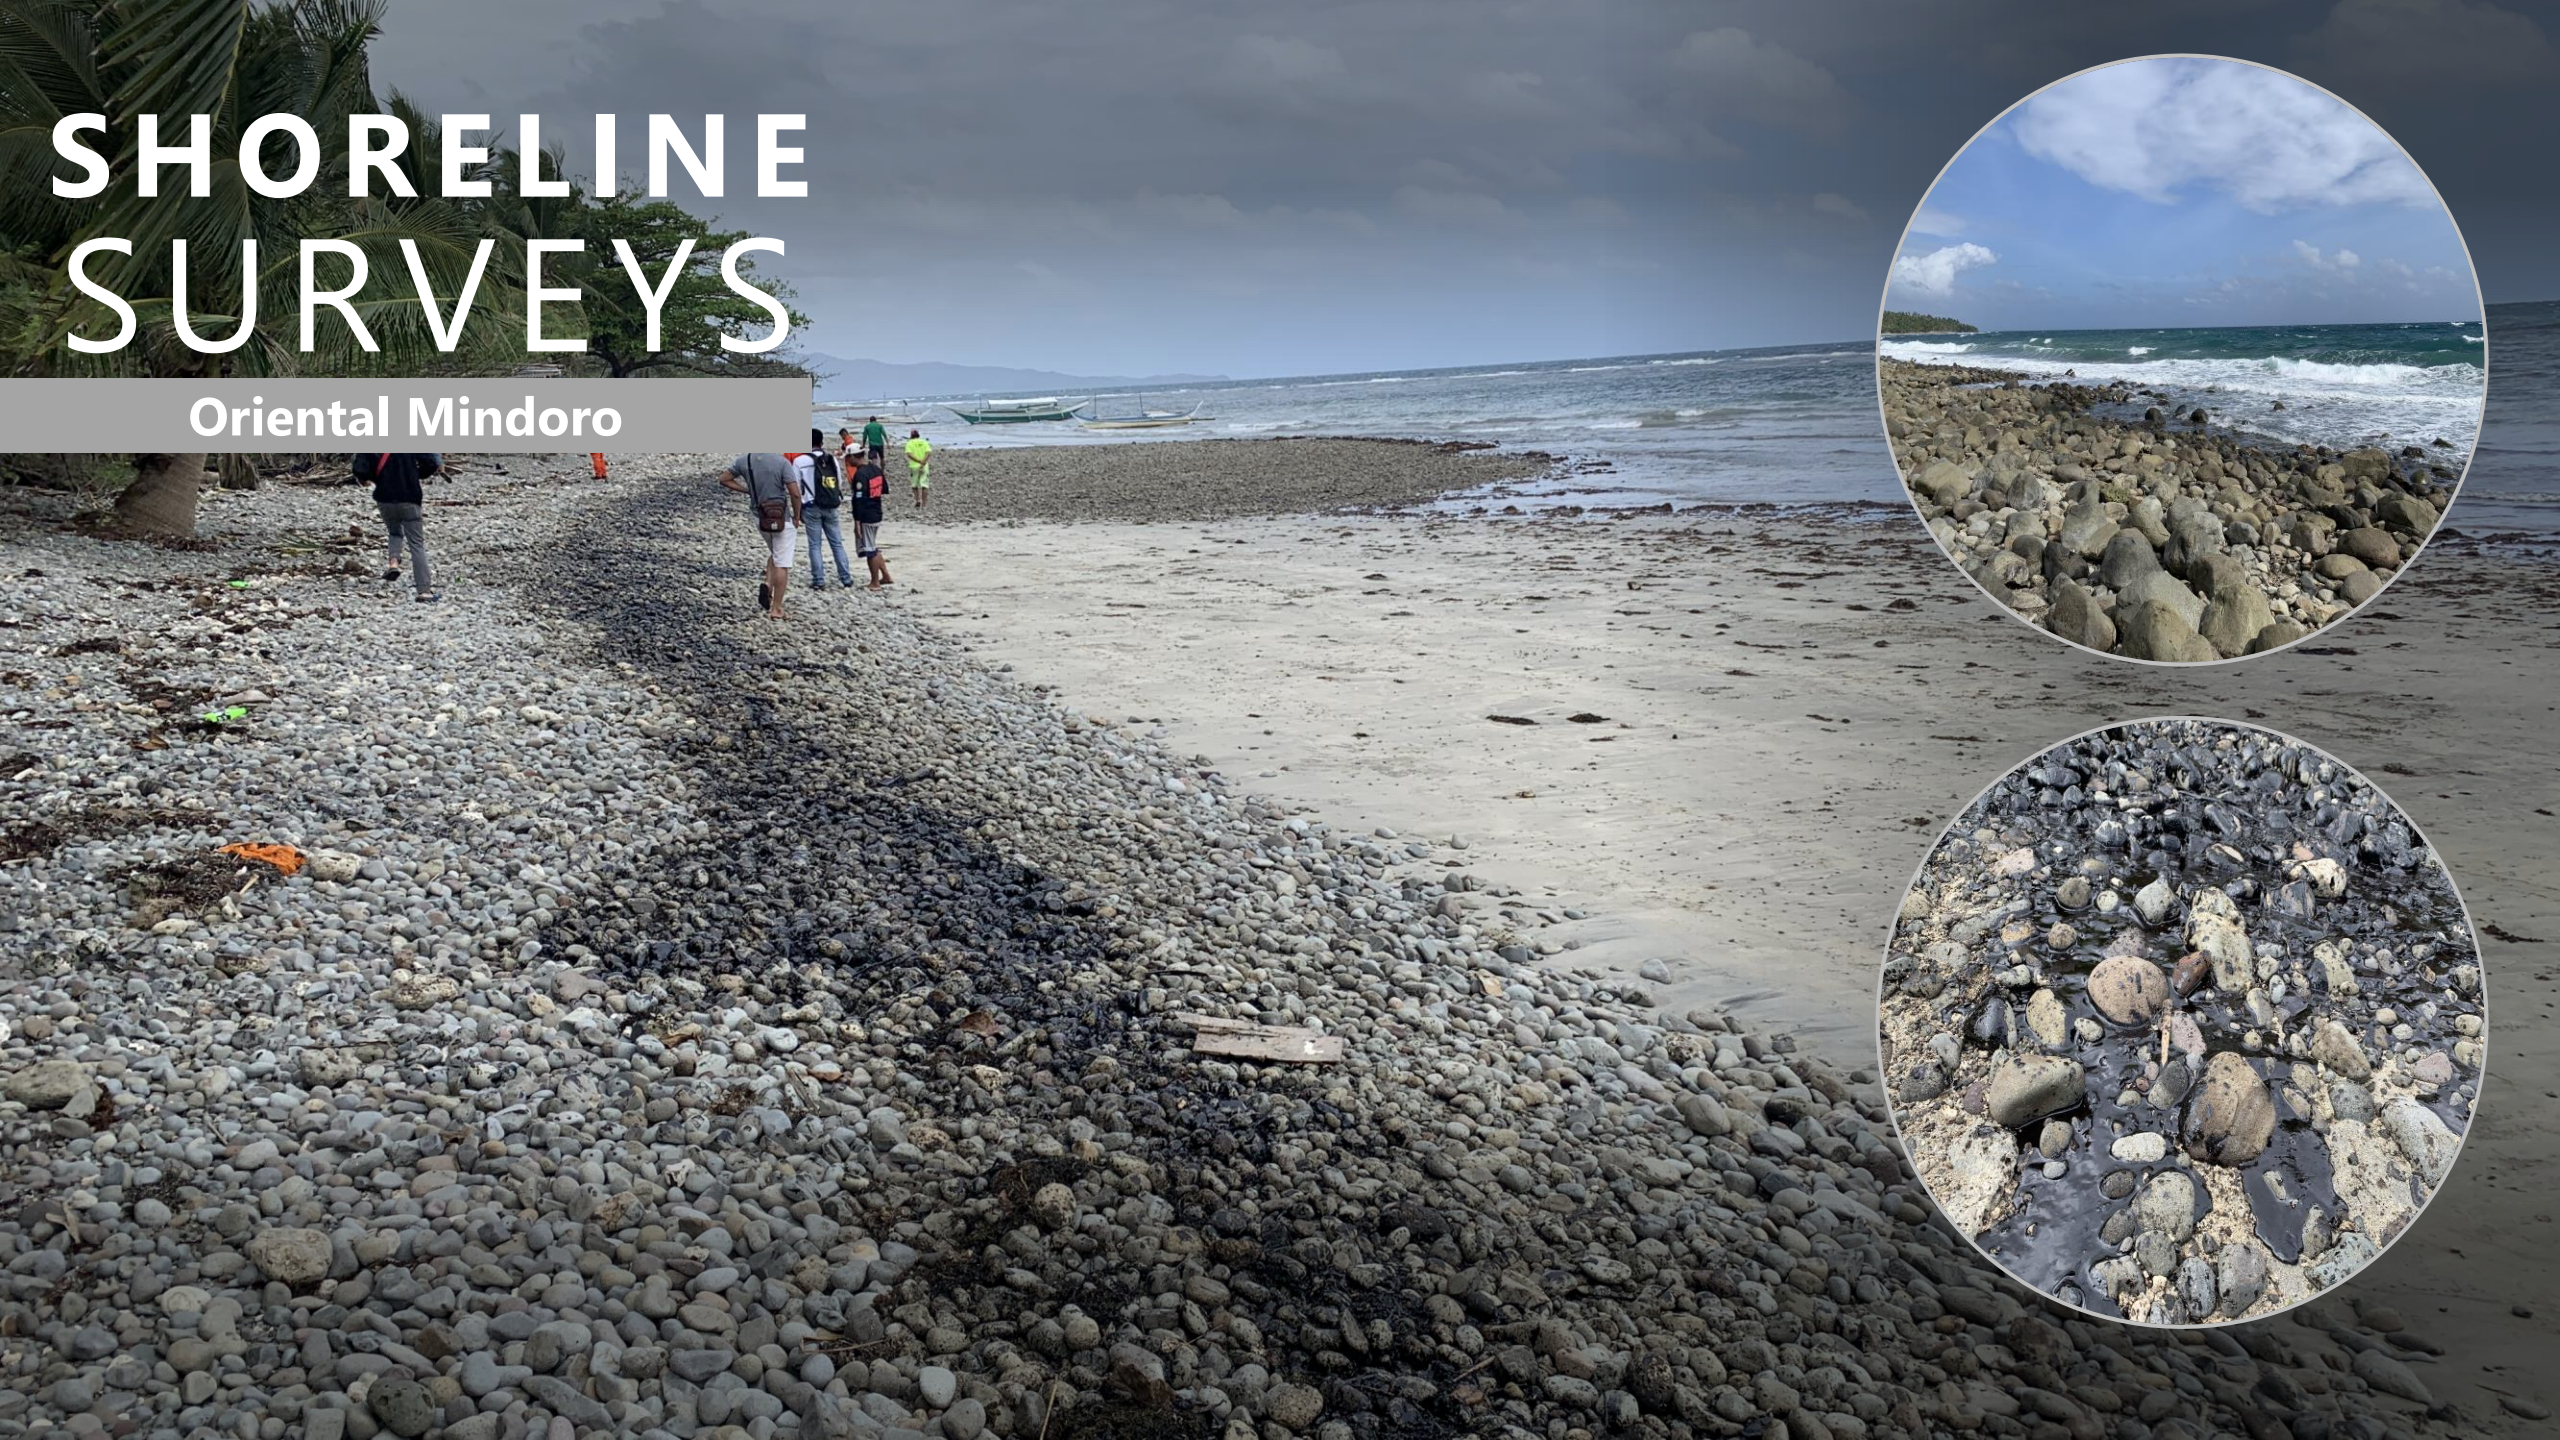
SITE Segment: Sabang F / Oonong A – B
 Barangay: Tinogboc

DATE 08/03/2023

SURVEY START LOCATION Lat: 12°02'27.3"N
 Long: 121°24'55.1"E

TOTAL LENGTH Segment: 1.40 km
 Surveyed: 1.40 km

NOTES Site is difficult to access – have to climb over large boulders to get from one beach to another. Some access routes available for fit and active responders. Further south cannot be surveyed due to no access by foot. High energy environment and therefore difficult to bring equipment via boat.

Length: ~ 120 m
 Lightly oiled:
 • Stains on pebbles and cobbles
 • No pooled oil noted

Oily waste debris present in this area. Continuous to patchy stains and coats on rocks.

Length: ~ 80 m
 Moderately oiled:
 • Covers on pebbles and cobbles
 • Oiled organic materials noted on the backshore

Some oil present within the pores of the coarse sediment.

Length: ~ 20 m
 Heavily oiled:
 • Organic matter and natural debris
 • Cobbles and pebbles

Continuous 20m band of heavily oiled debris and sediment. Liquid oil is present escaping from between the pores.

Length: ~ 200 m
 Lightly oiled:
 • Tar balls
 • Heavy staining on the strandline
 • Sporadic oiled debris

Frequent occurrences of oil-impregnated sand, oiled plastic waste and debris.

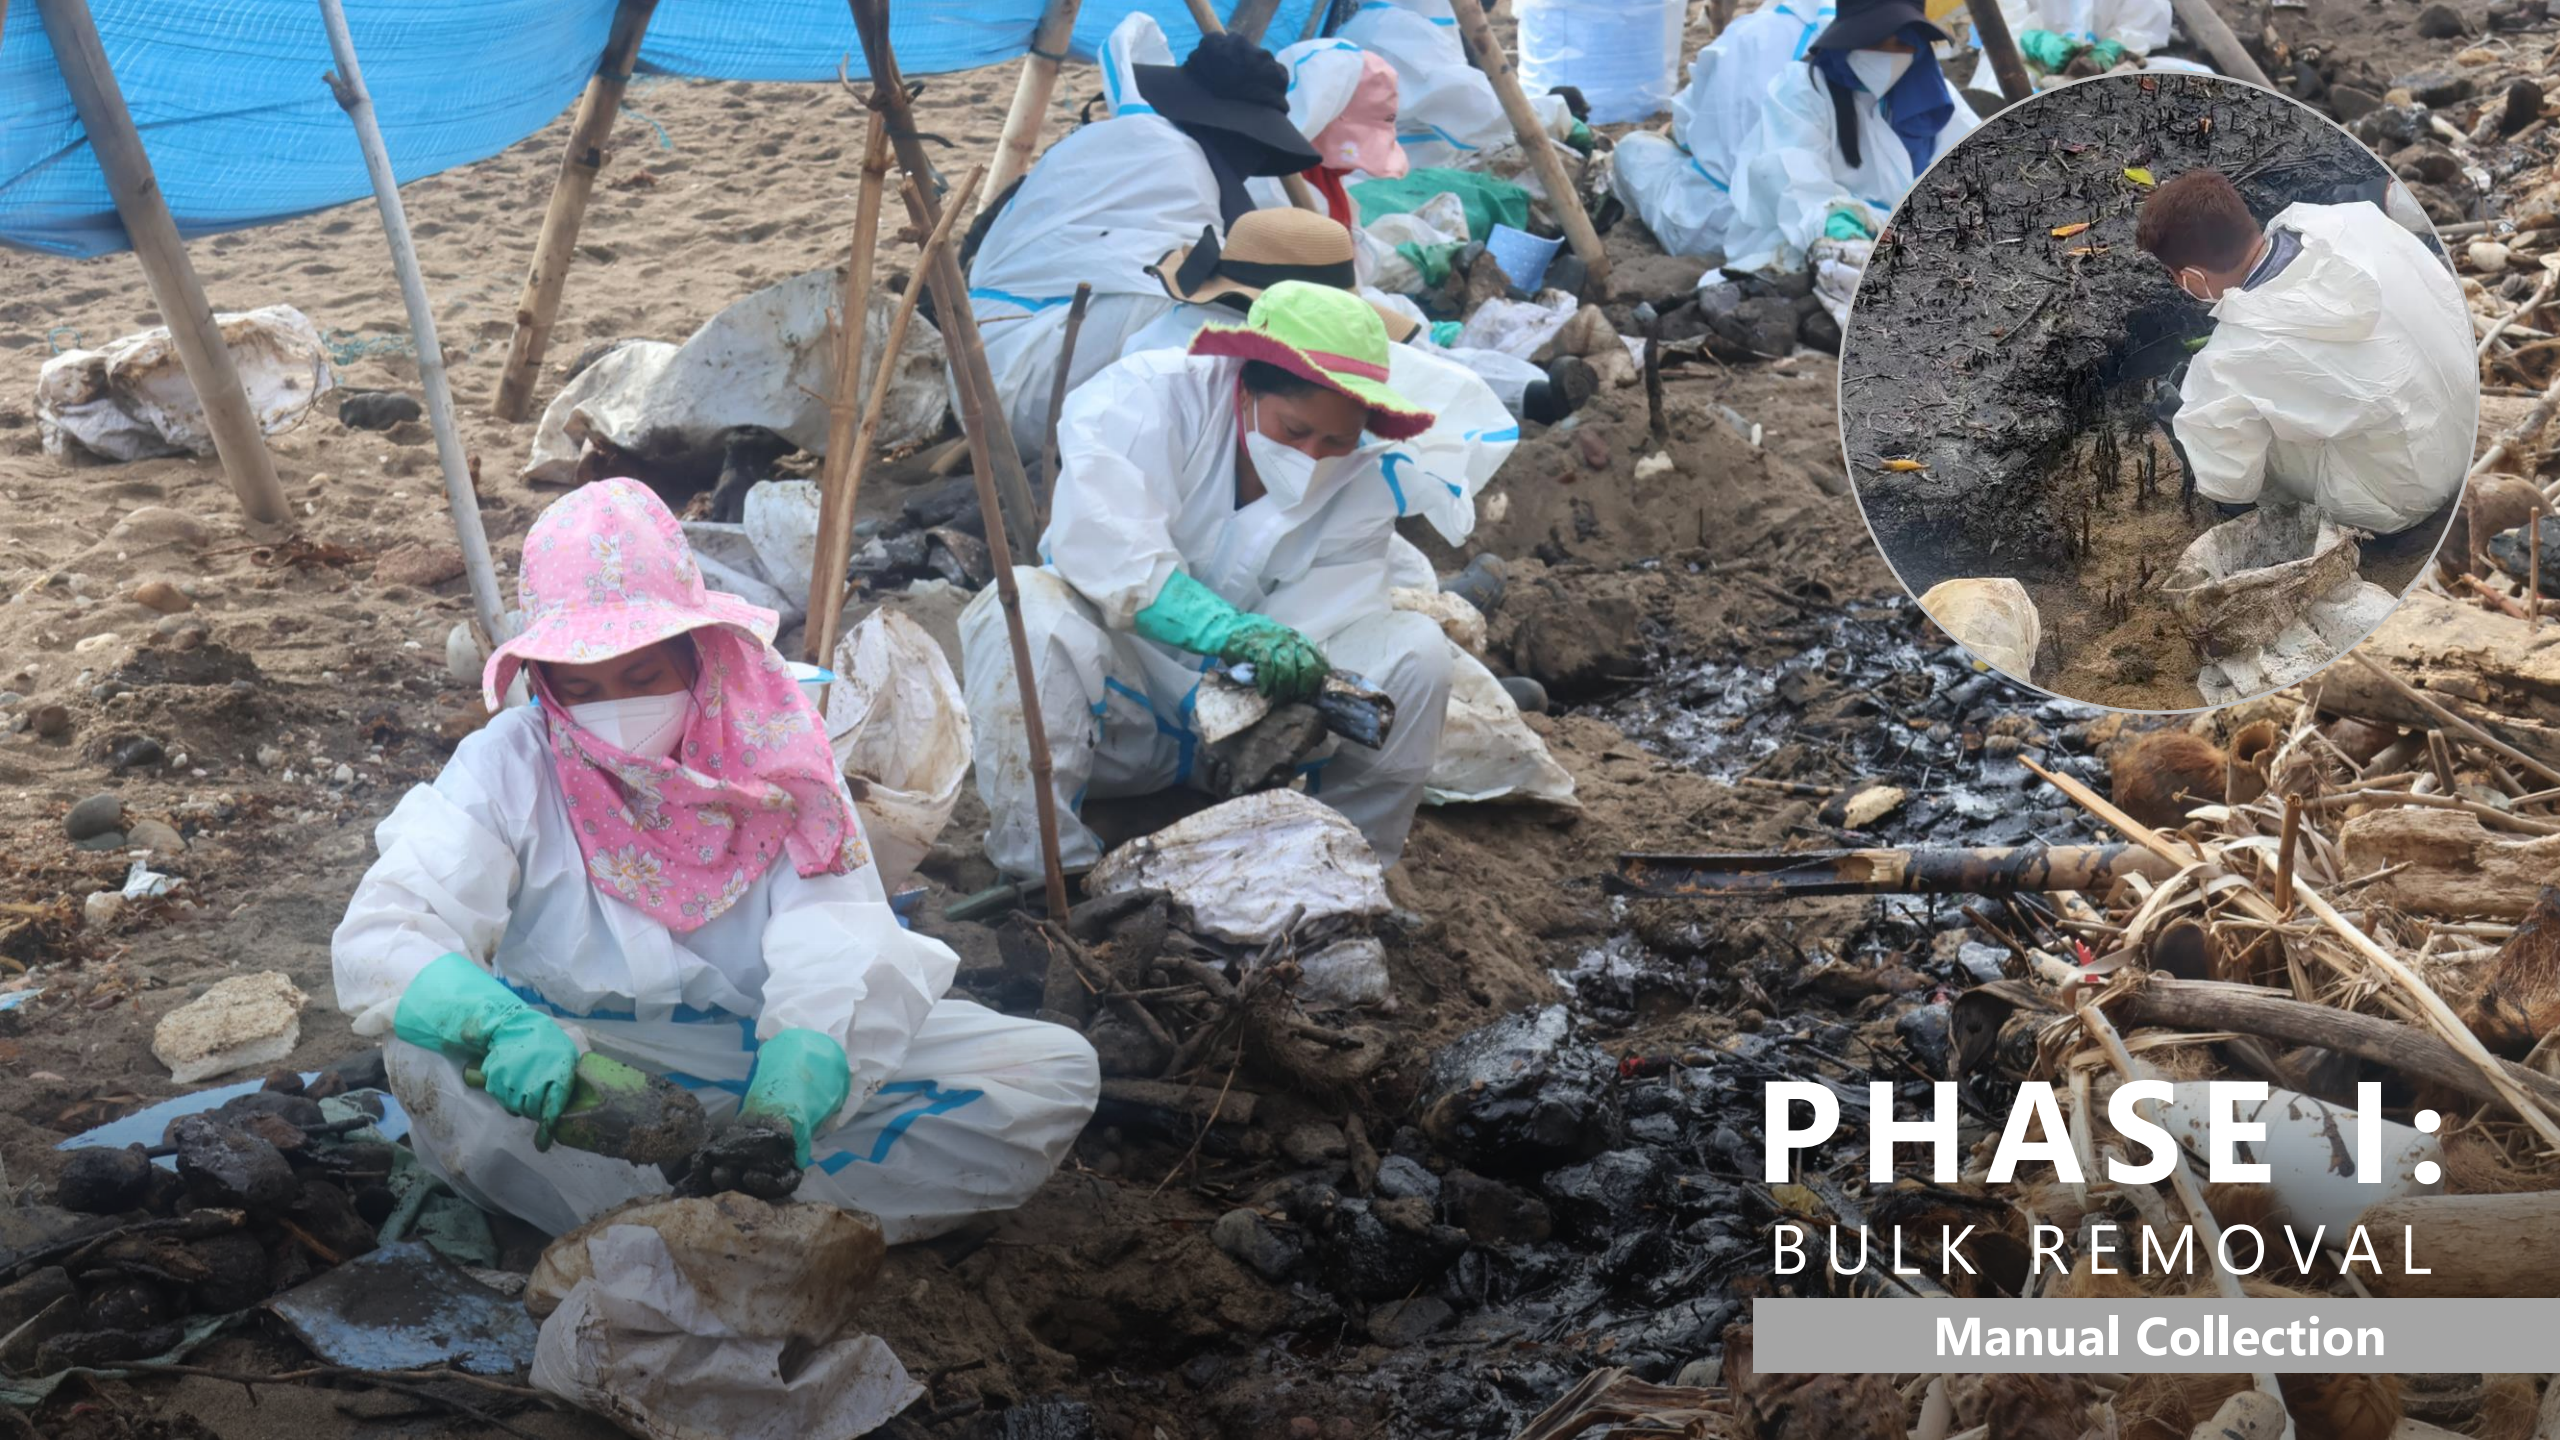
PHASE I:

BULK REMOVAL

Manual Collection

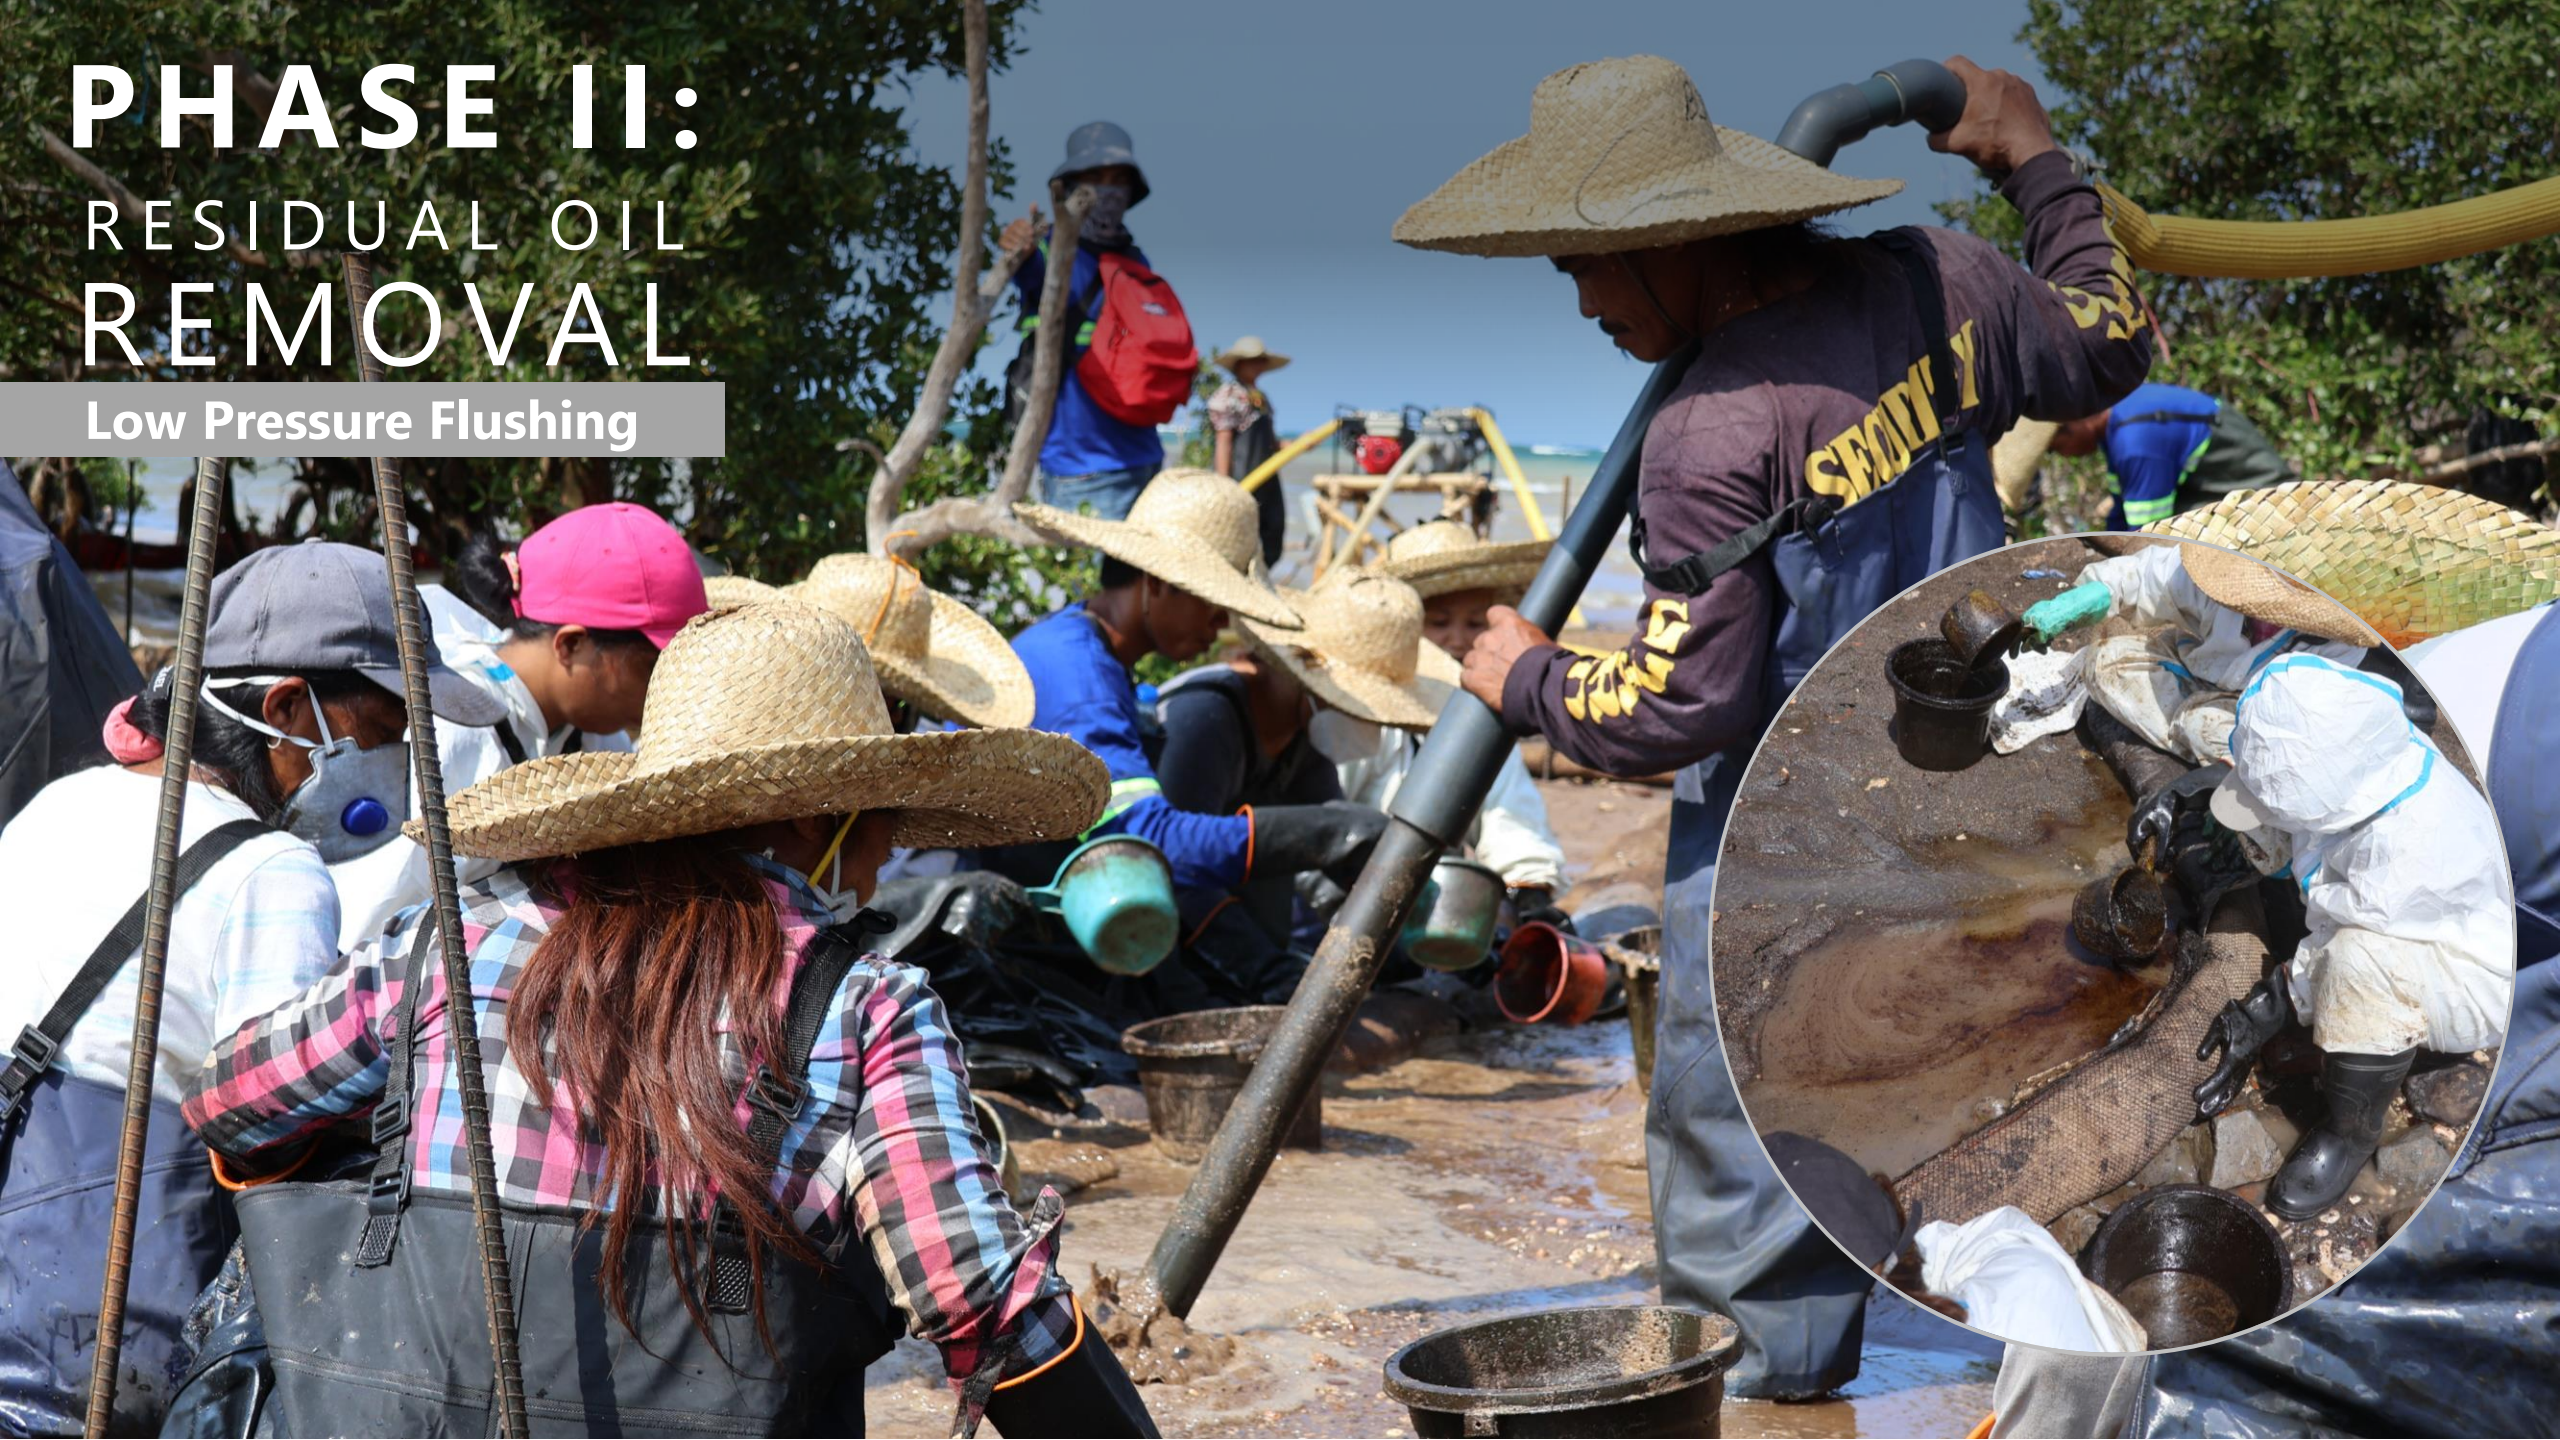
PHASE II: RESIDUAL OIL REMOVAL

Low Pressure Flushing
