Tanker Structure and Hull Failure Strength

Hajime Kawano and Masaru Hirakata,
National Maritime Research Institute, Japan.

3-2. Case study

Outline of the Nakhodka casualty

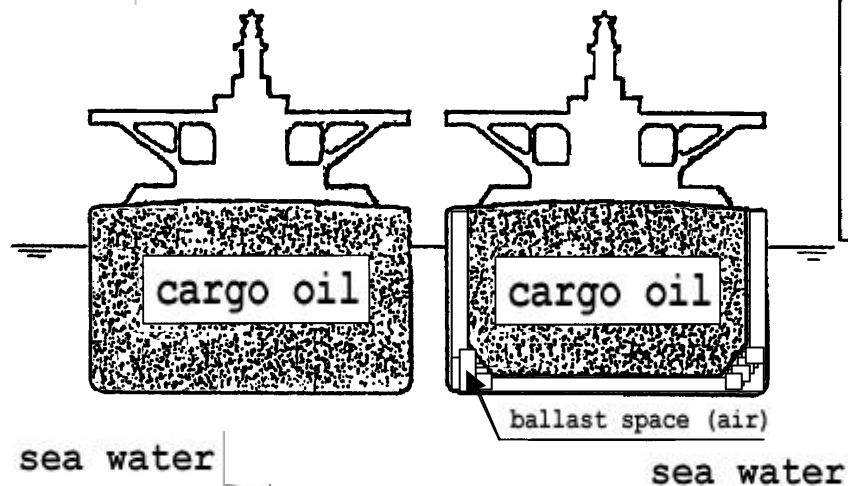
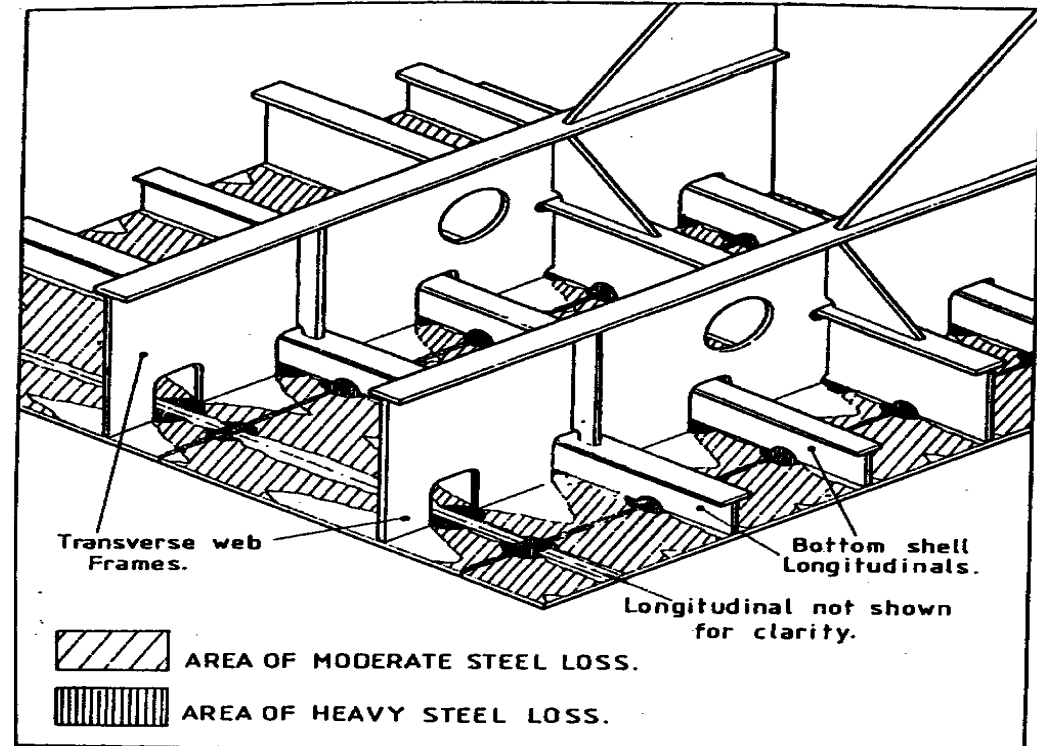
- Corrosion in bottom plating ;**
- 1) horizontal/vertical plating
 - 2) splashed zone or not
 - 3) effect of fluid velocity
 - 4) effect of high temperature, etc

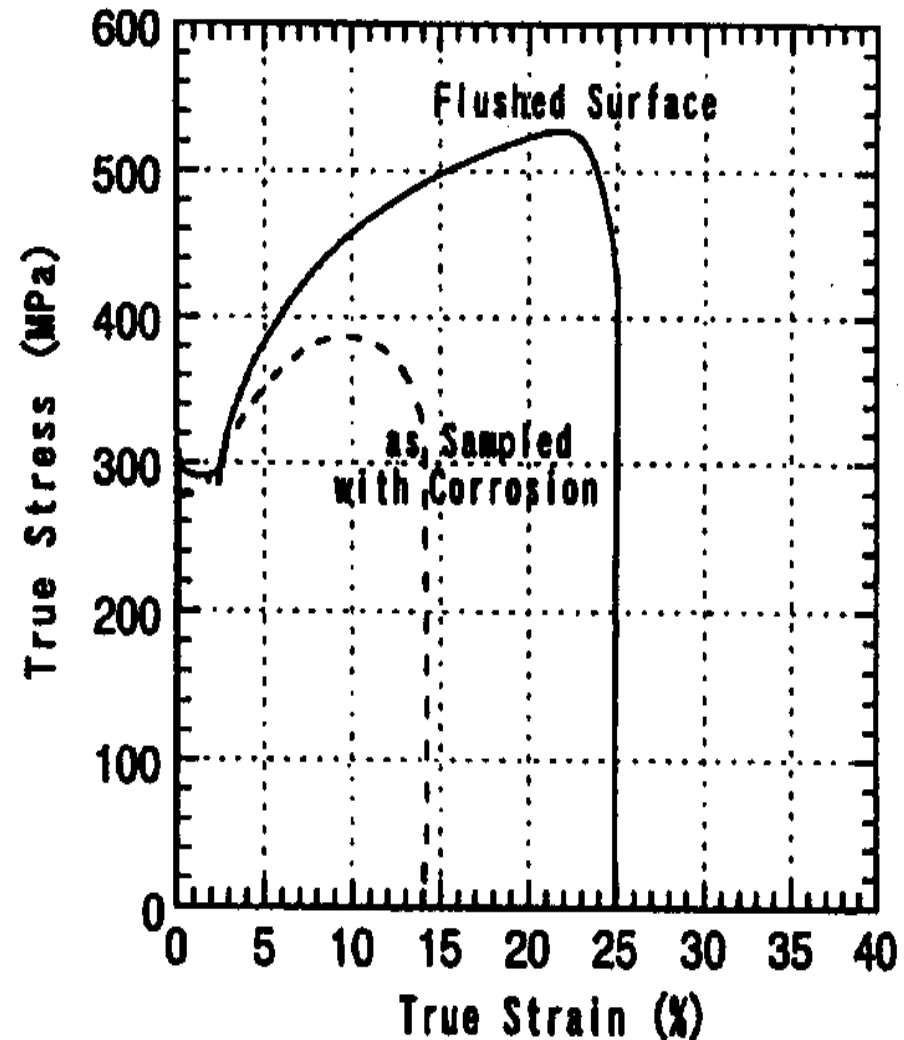
Stress vs. strain curve of aging plate;

- Cut-out and flushed specimen shows no less ability to virgin plate.
- Apparent drop in S-S curve for aging plate is by surface roughness due to corrosion.

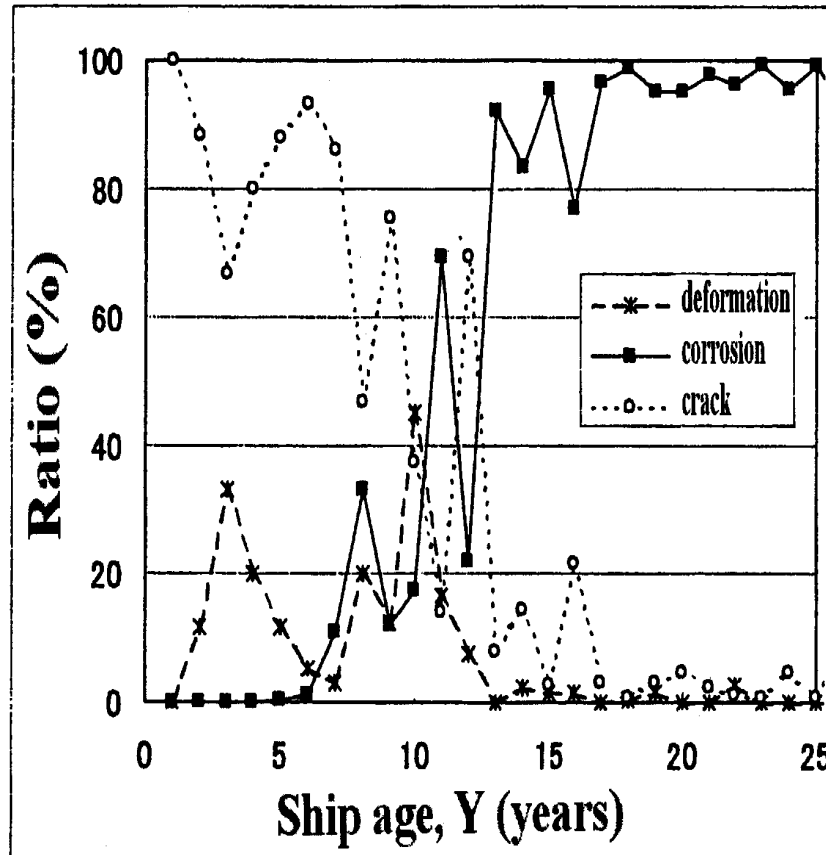
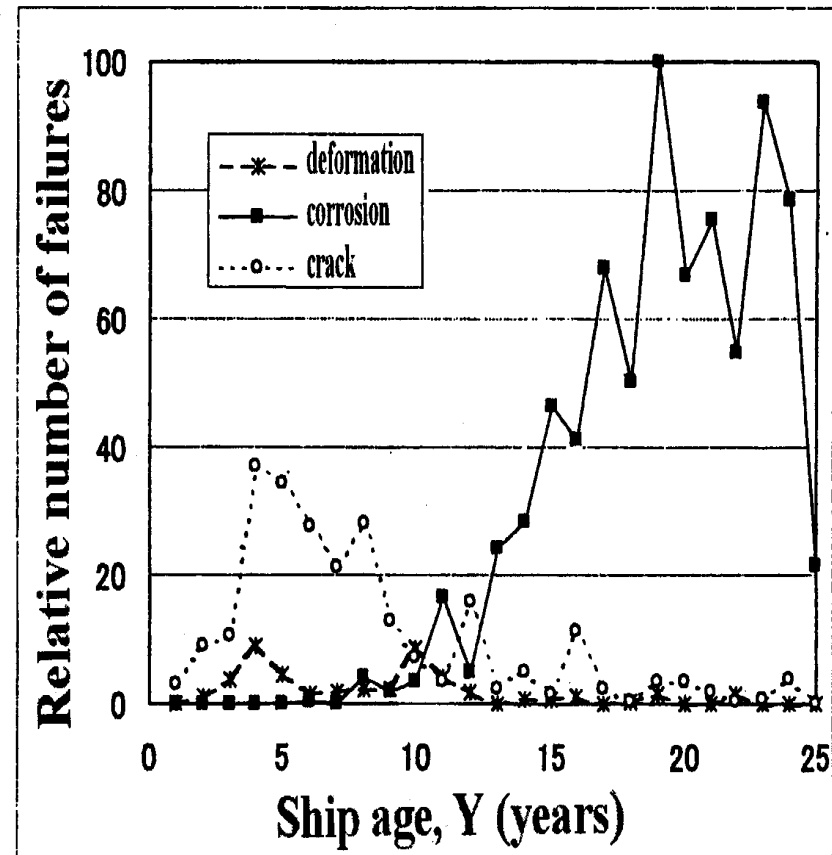
Degradation tendency with increase of ship age

(a) Trend in degradation mode

(b) Trend in number of failures

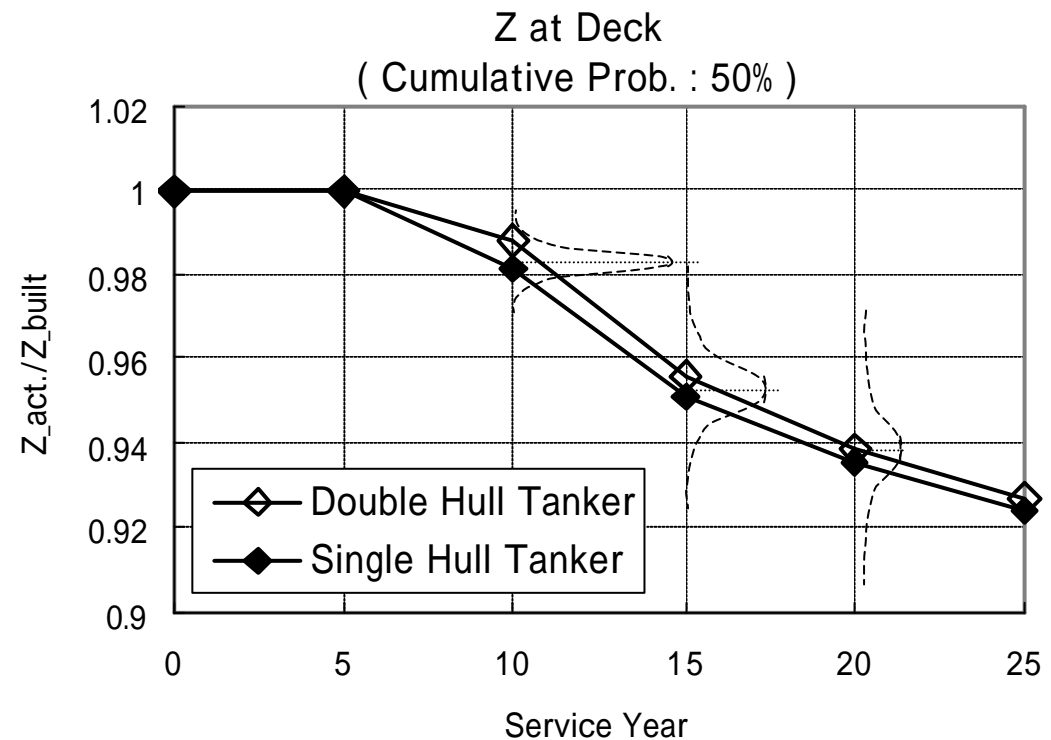
Estimated results on average tendency of the VLCC mid-ship section modulus;

- (1) IMO requirement :
within 10% loss of Z
- (2) Average corrosion damage is within IMO requirement.

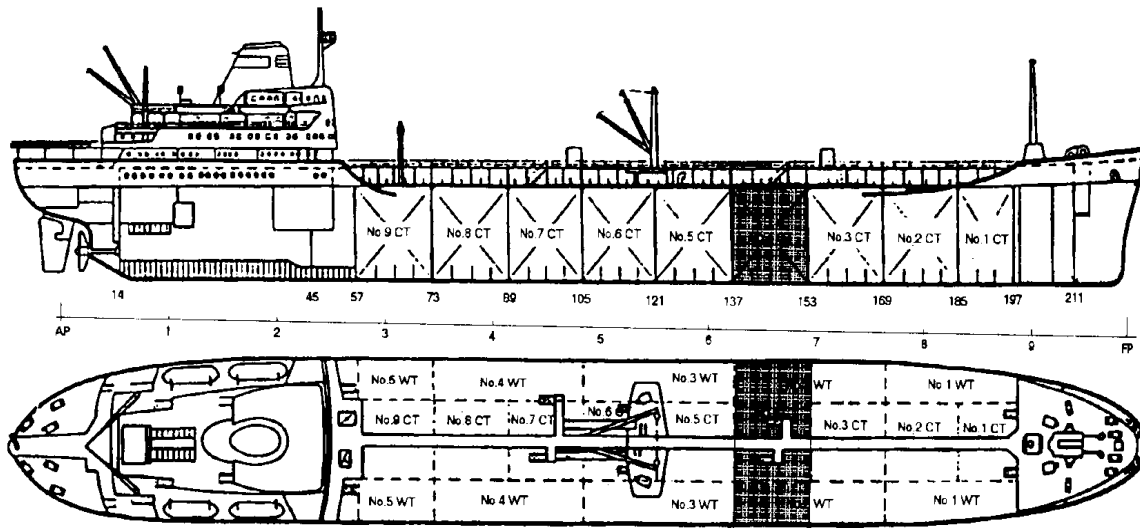
General Arrangement of the MS Nakhodka

Fr.137 Fr.153
Failed and broke in two

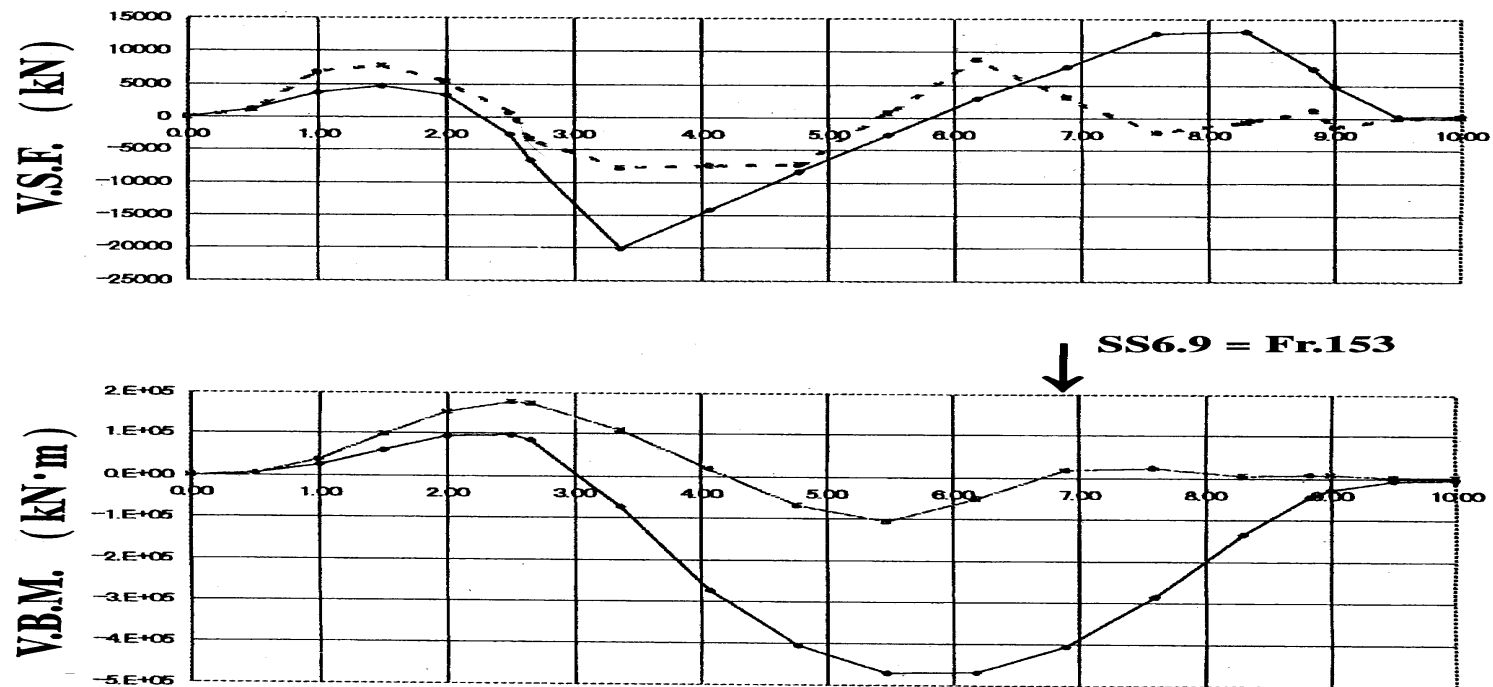
**Still water shearing force and bending moment
for the Nakhodka**

VBM and VSF were obtained by using non-linear ship motion and response simulation software.

(solid line : at the accident, dotted line : standard condition)

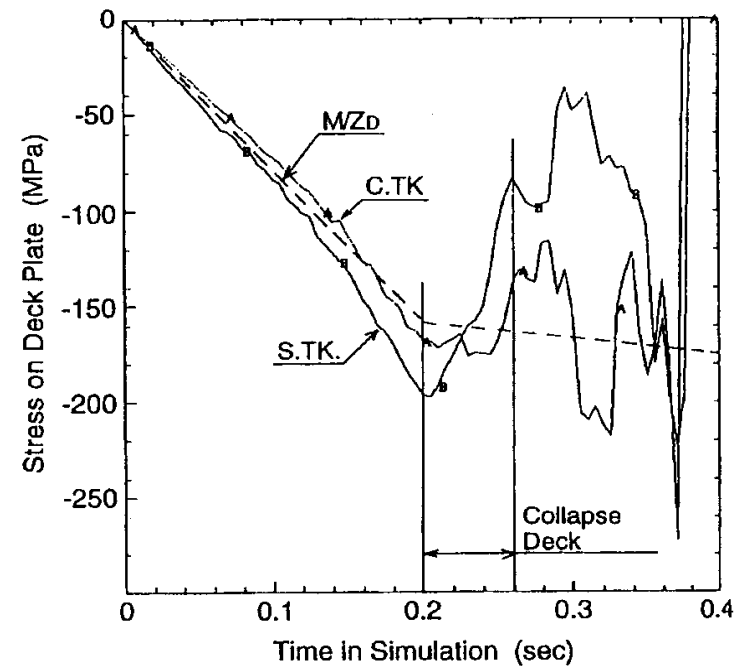
(b) stress at deck vs. time in simulation

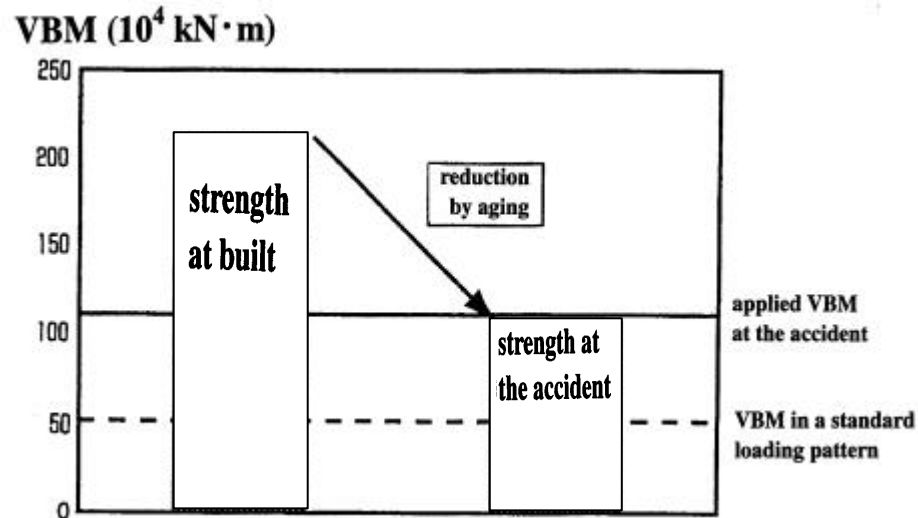
Estimated results on load and strength

Causes of the Nakhodka casualty;

- (1) *Excessive corrosion* made the Nakhodka's vertical bending strength about one half to that of as built.
- (2) So, the most *severe wave load* in a year at Japan sea, let her broke up.
- (3) In addition to the above, the *non-standard loading pattern* at the accident had enlarged the wave load.
