Summary of Chemical Tanker Accident at Kumano-nada, Japan

Mitsuyoshi NOMATA
Director,

Marine Environment Protection & Disaster Prevention
Division, Guard & Rescue Department
Japan Coast Guard

Outline of the Accident

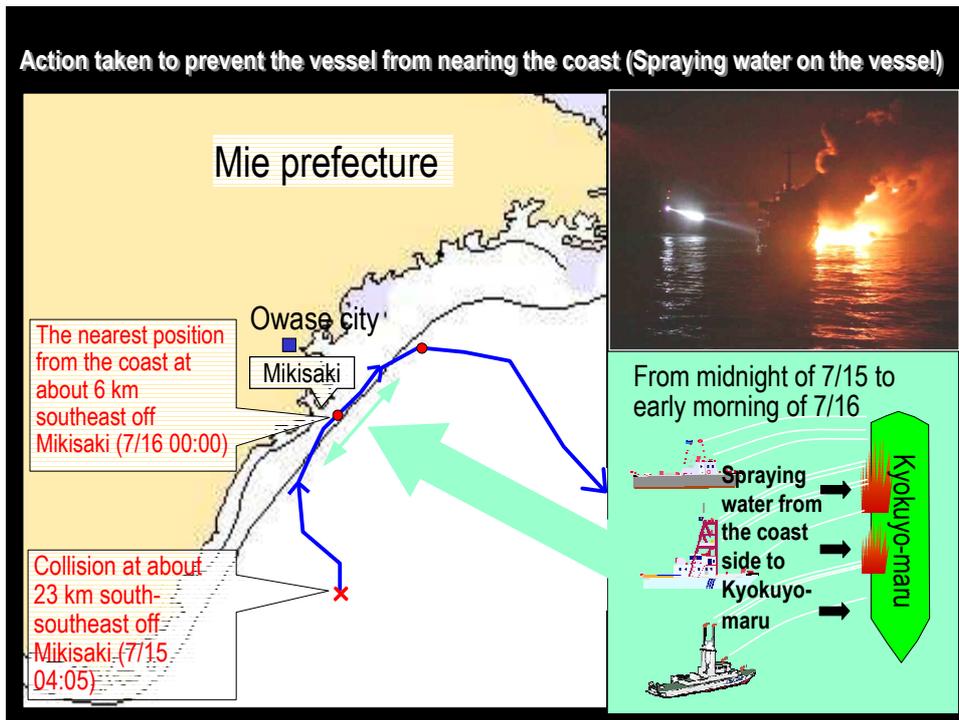
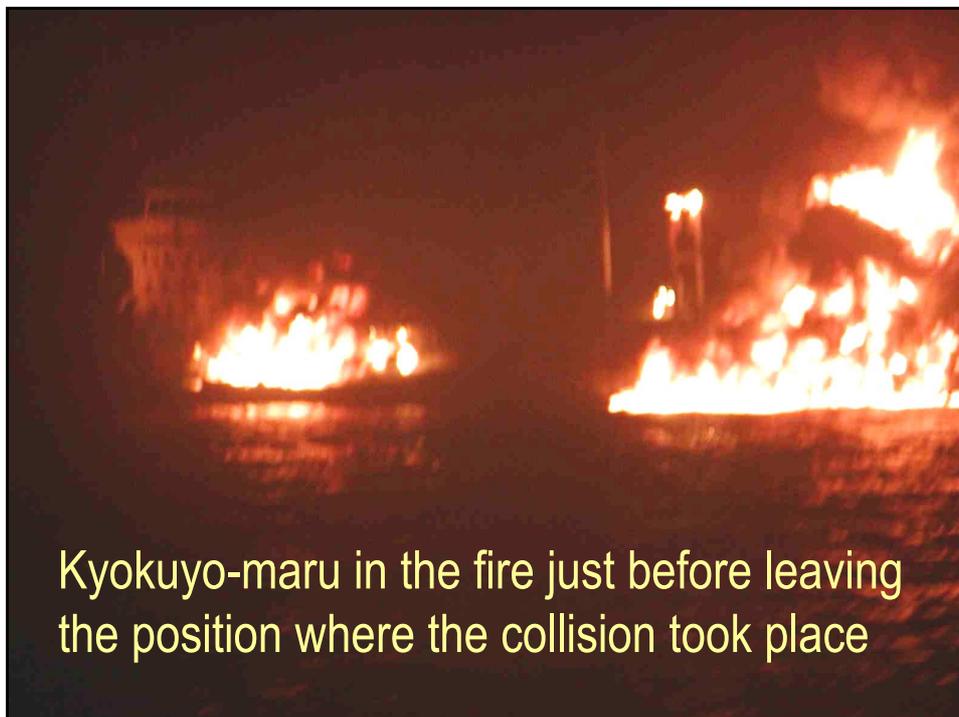
Undertaking towing (2nd day)

04:30 The fire began to die down.

⇒ Fixing a towing wire was discussed.

05:43 Special Rescue Team boarded the vessel and fixed the towing wire.

07:10 A patrol vessel started towing toward the open sea.

Fire-extinguishing was successfully undertaken again.

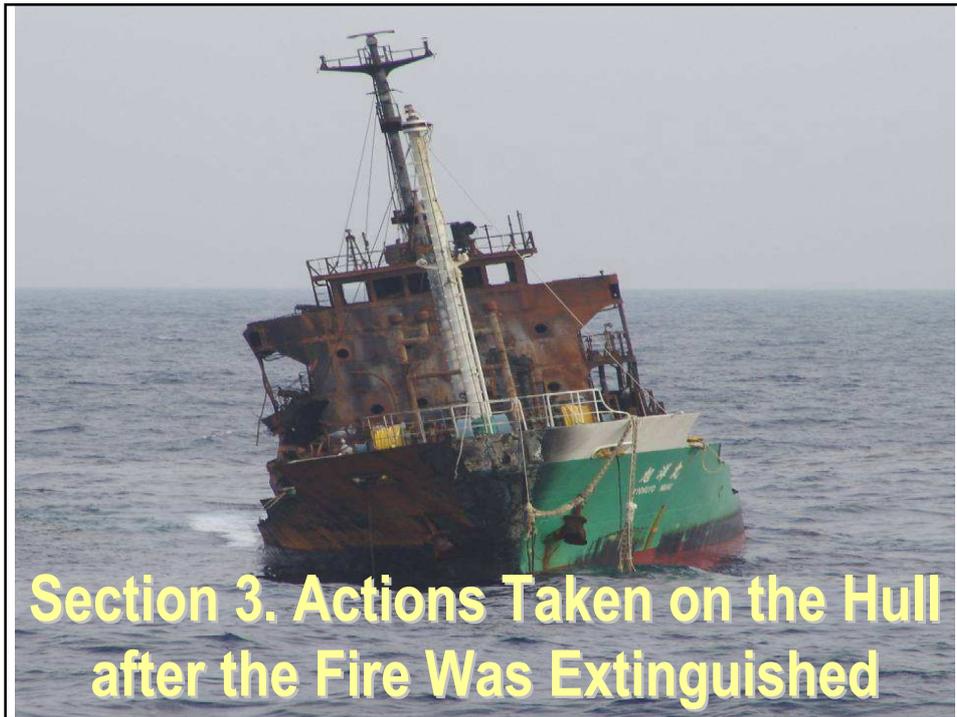
Actions Taken on the Hull after the Fire Was Extinguished

- Joint investigation of the status of the hull structure by the National Strike Team, a salvage company, and specialists assigned by the ship owner

- Possible re-ignition due to continued leakage of flammable gas from the cracks on the hull

- With 20-degree heel to the starboard side, risk of overturning and submergence increased

Emergency repair and transshipment of cargo etc. were difficult.

As a typhoon approached, towing was started off the coast on July 22 at the request of the ship owner.

On July 23, the Kyokuyo-maru sank while being towed (59 miles off the coast, depth of water: 4,400 m).
